NORTH SEA FLOW MEASUREMENT WORKSHOP 1993
26 - 28 October, Bergen

*Scaling problems in the oil metering
system at the Veslefrikk Field*

Mr. Kåre Kleppe/Mr. Harald B. Danielsen,
Statoil
Norway

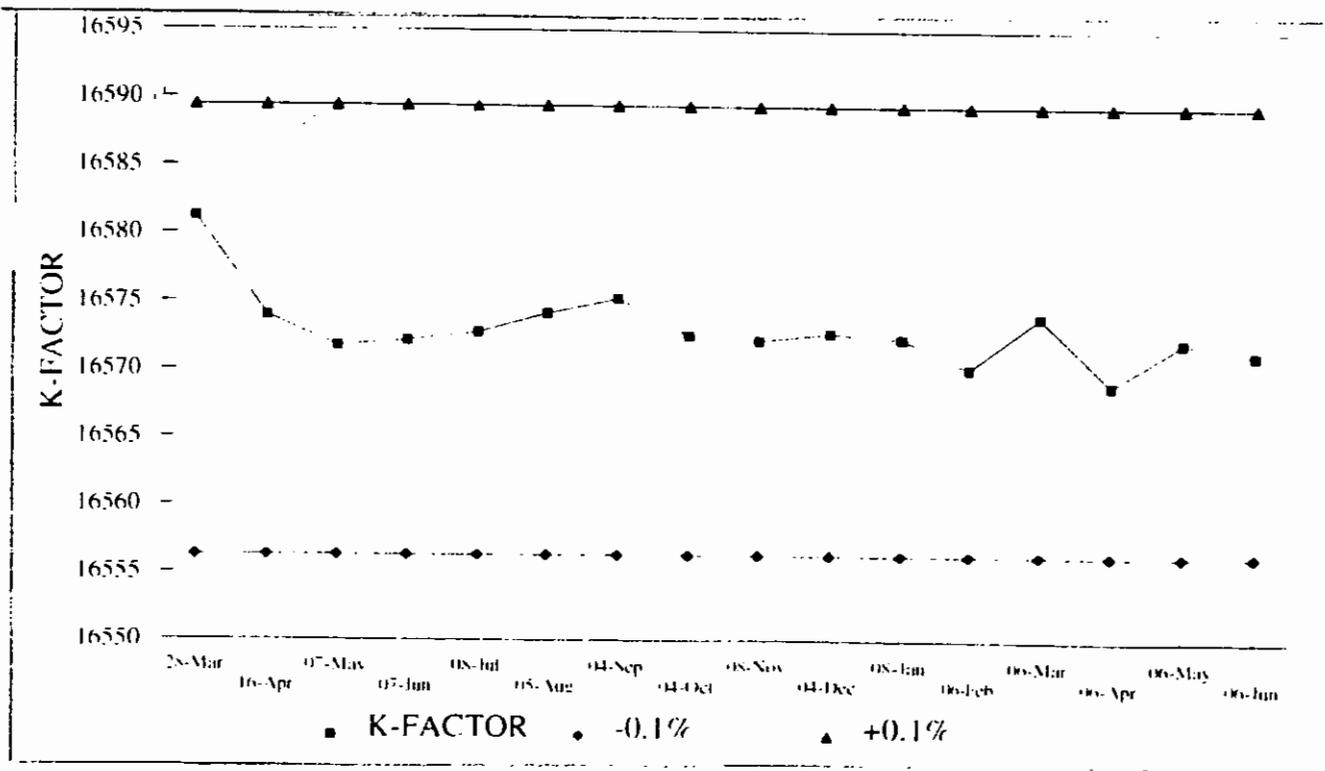
Up to this time the K-factors had been almost constant, but suddenly there was a daily increase of the order of 0.3-0.6 % per day. Figure 2 shows the K-factor of one of the meters during a period of 15 months before the start of the scaling problem.

Fig. 2 Before the scaling problem, typical K-factor values as a function of time for one of the turbine meters.

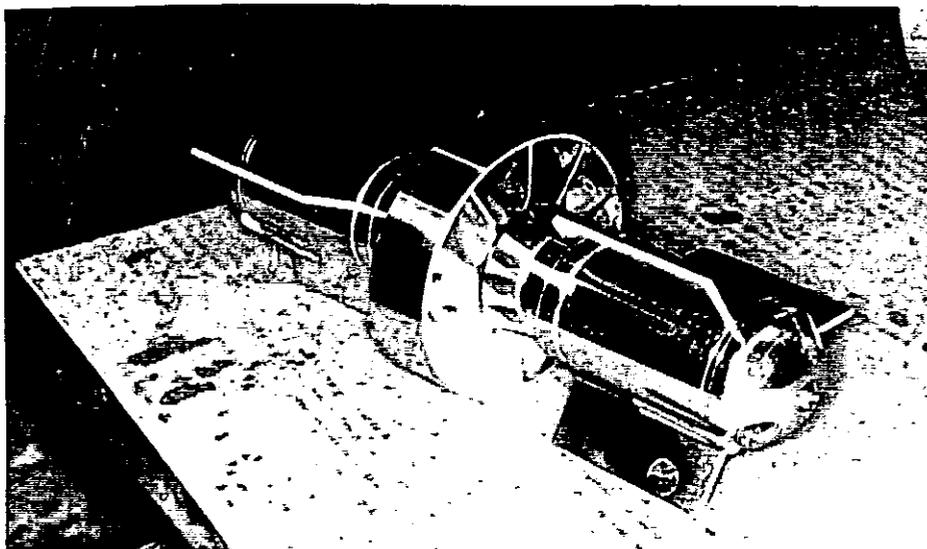
Also, a turbine meter with polished internals was installed on 15th august this year. Fig. 9 indicate very clearly why we think polishing will be the solution to the scaling problem in the meter runs.

Fig. 7 shows this turbine meter.

Fig. 7 Polished internals of turbine meter

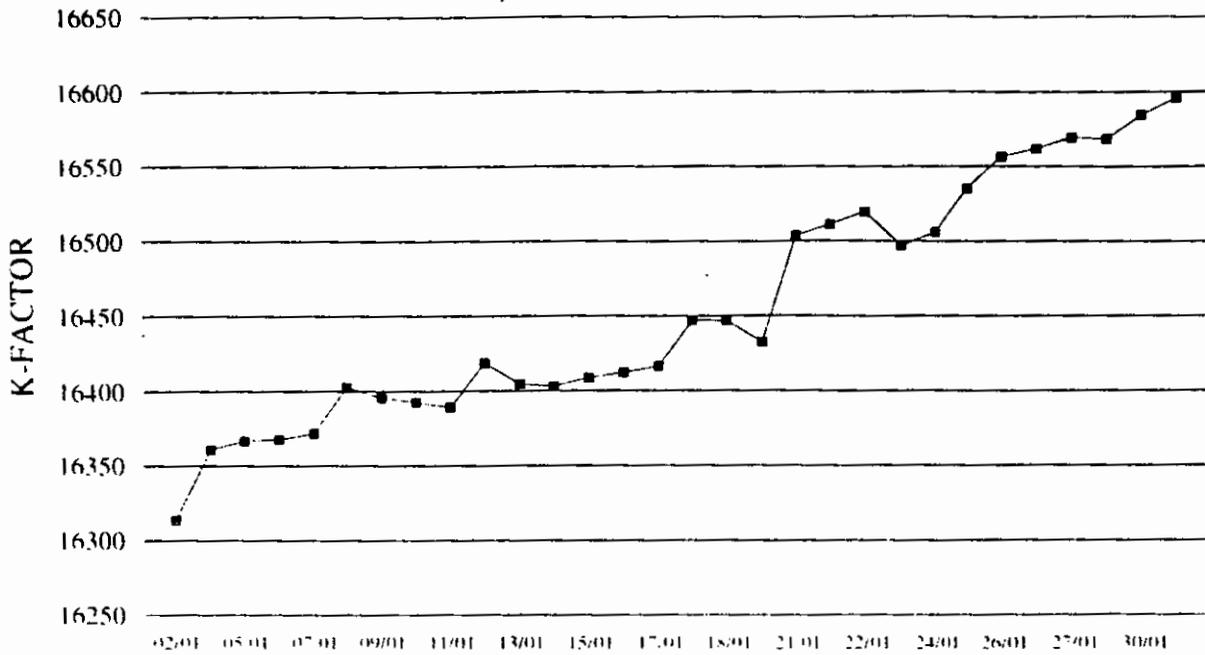
A graph showing typical drift of the K- factor of one of the turbine meters during January 1993 is shown in fig. 8. There is an irregular increase of K-factor from day to day leading to a maximum value about 2% higher towards the end of the month than at the beginning of the month.

This graph shows less drift of the K-factor than at the time when the problem started. This is mainly due to that scale inhibitor is in use in the period shown on the graph.

Fig. 8 Typical K-factor values as a function of time in a time period when scaling takes place and scale inhibitor is being used.

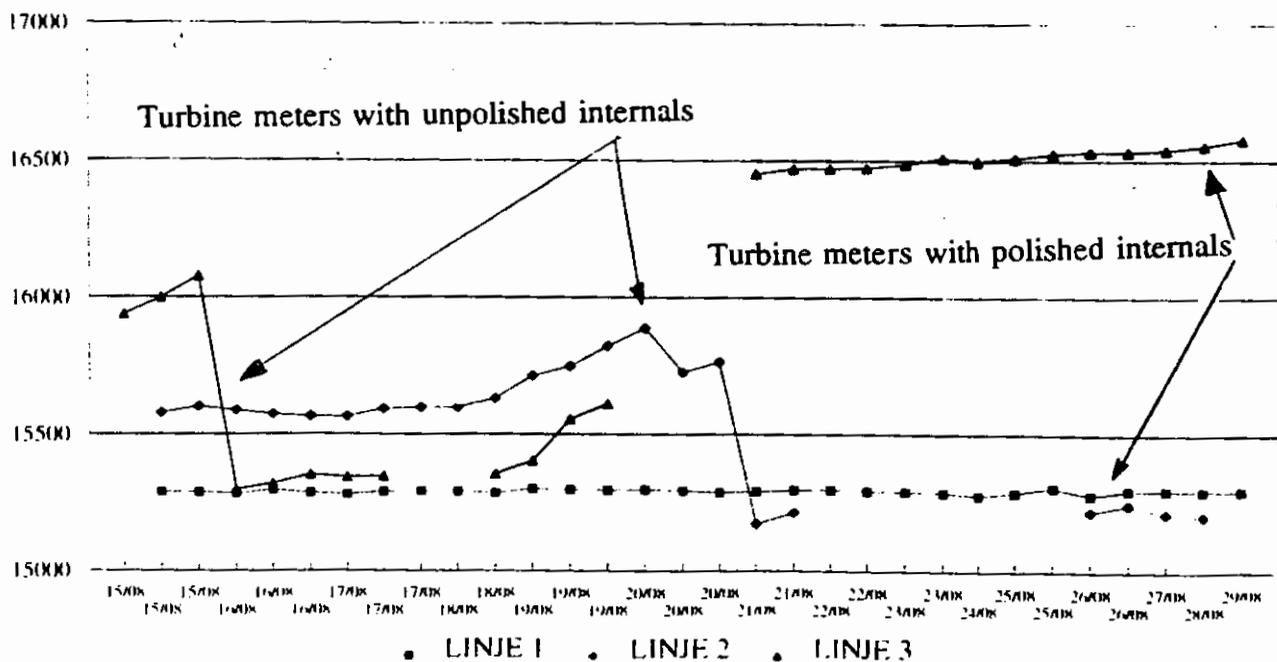
Fig. 9 K-factor values for turbine meters with and without polished internals.
