Paper 2.3

Dirty VS. Clean Ultrasonic Gas Flow Meter Performance

*John Lansing
Daniel Industries*

*Tom Mooney
Emerson Process Management*

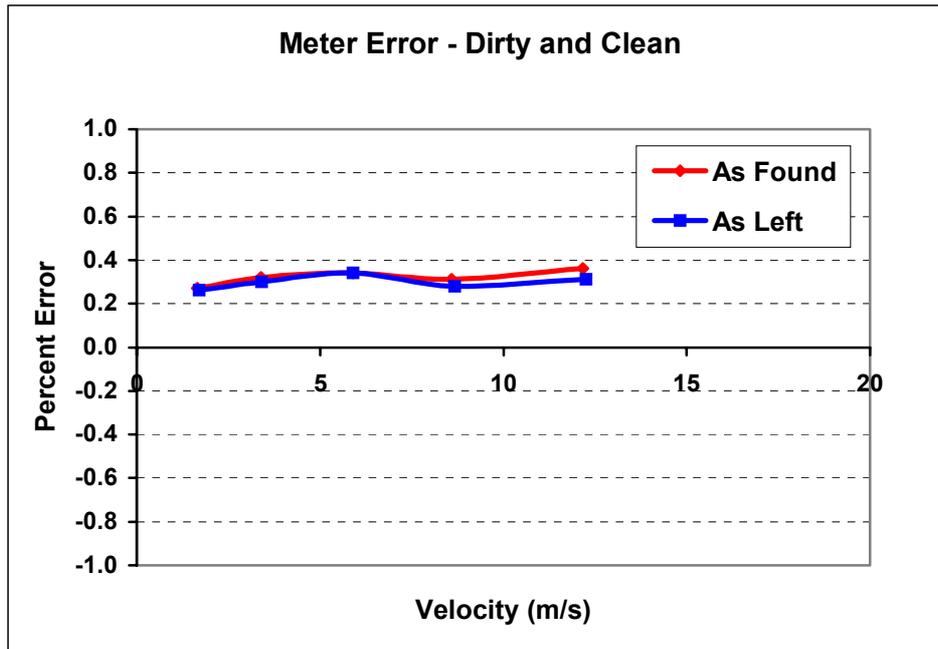
Figure 2 – 24-Inch “As-Found” and “As-Left” Meter Results

It's important to remember this ultrasonic meter was never calibrated. This explains why the performance was approximately 0.3% fast in Figure 2. Taking the raw data and determining a Flow Weight Mean Error (FWME), as described by AGA 9, for the dirty meter would result in a meter factor of 0.9966. After the meter was cleaned the FWME would have been of 0.9970 (same velocity points used as for the dirty meter results). In other words the meter factor changed by 0.04% from dirty to clean (meter reading on average was slightly lower after cleaning).

Unfortunately there were no measurements taken of the buildup thickness inside the body or associated spools. Thus, it is difficult to determine how much the cross-sectional area might have changed from dirty to clean. Nevertheless, from the above photos it can be seen that this is a dirty meter. In spite of the amount of contamination the meter, flow conditioner, and associated piping had, the meter's performance was affected by approximately 0.04%. Since this is well below the uncertainty of the calibration facility, the difference between dirty and clean could be considered negligible.

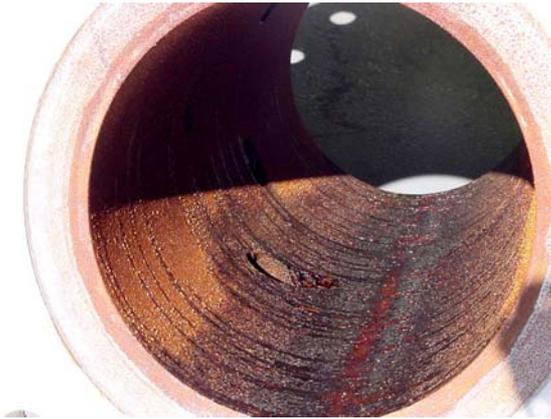
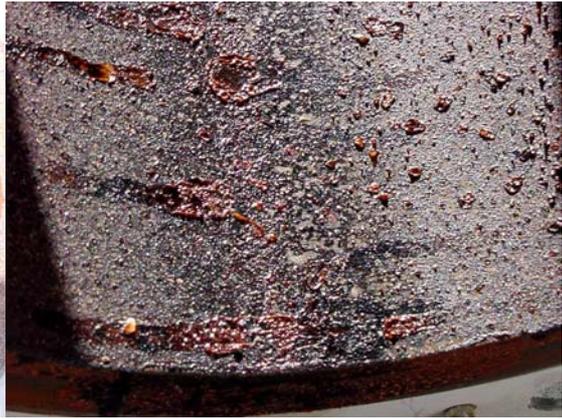
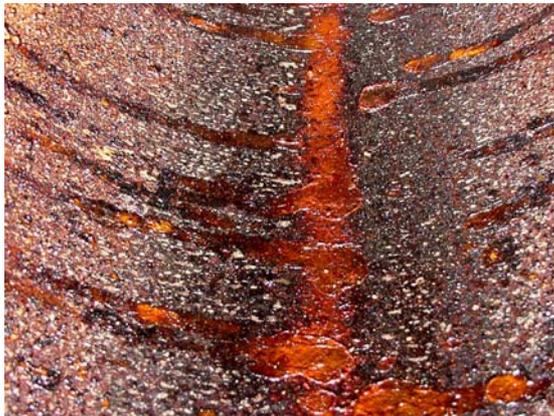
As can be seen in these pictures, the meter body had a significant buildup of an oily, gritty substance (Pictures 7-9). What isn't clear in the picture is the fine mill-scale buildup under this coating. After careful removal of this material it was measured and found to be approximately 0.010 inches in thickness. A surface roughness gauge recorded mill scale readings of 473 μ in. After the mill-scale was removed, the roughness reading of the meter body was 125 μ in.

As was mentioned earlier, the meter body had a mill-scale buildup of about 0.010-inch. This buildup effectively reduces the cross sectional area of the meter causing the velocity to increase for the same given flow rate. This would result in a meter reading faster when compared to its clean condition. However, the meter registered slower when dirty as compared to when it was clean.

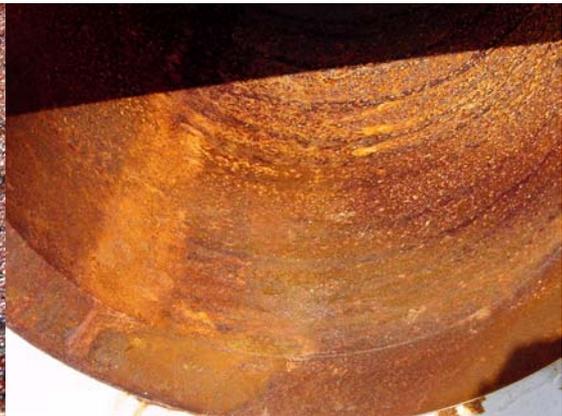
Picture 10 –Upstream Spool Piece

All of the upstream meter spools had much less oil on them (Picture 10) than the meter body. This is due to the fact that the meter assembly was removed late in December and stored for several months. Unfortunately the spools were not protected from the atmosphere as well as the meter body was. Thus, it is probable the oily substance in the upstream and downstream spools evaporated over time.

A surface roughness gauge was placed in the upstream spool (3D in length) and the intermediate spool (3.5D in length) that is located between the plate and vane. The roughness reading on the 3D spool was between 201 and 377 μ in. The roughness on the 3.5D spool was between 323 & 394 μ in.

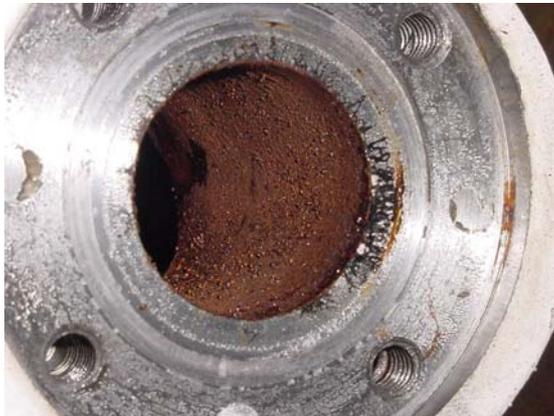
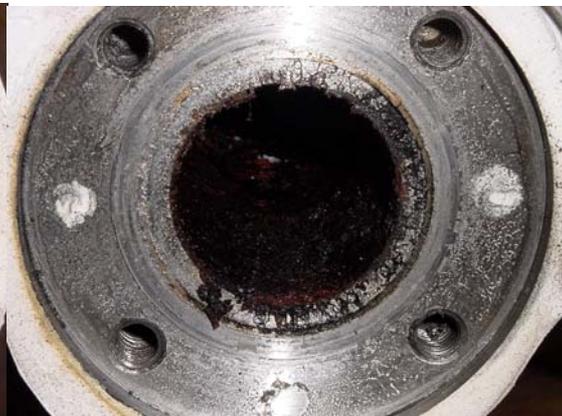
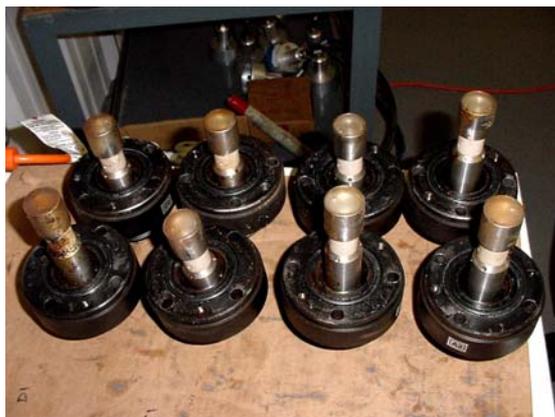
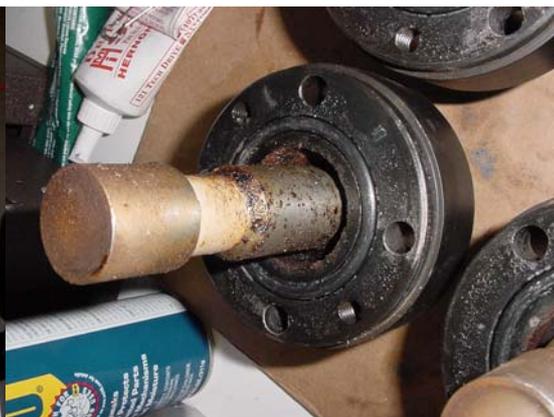
Upon inspection of the ports in Pictures 11-12 one can see there is a very oily, gritty buildup of material. Note the face of the transducers in Pictures 13-14. They are all very clean. The dirtiest one, shown in Picture 14, was located closest to the bottom of the meter body, and faced upstream. Since these transducers do not protrude into the stream, their faces remained extremely clean. This is important since any coating on the face will impact the meter's accuracy [Ref 9].

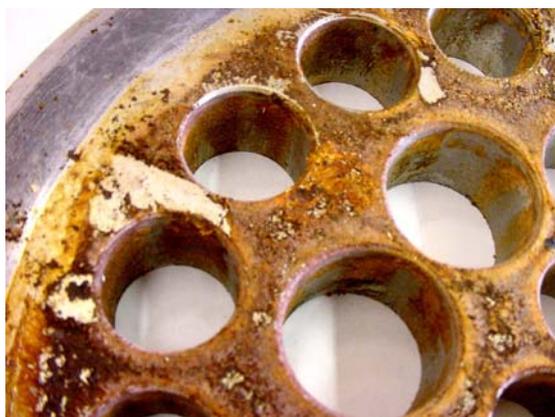
Picture 15 – Flow Conditioner Plate

Picture 15 shows the the flow conditioner had a consistent buildup. Upon close inspection it is obvious the holes were coated throughout. There was more buildup on the face of the plate

than there was relative to the inner surface of each hole. The vane, shown in Picture 16, remained fairly clean.

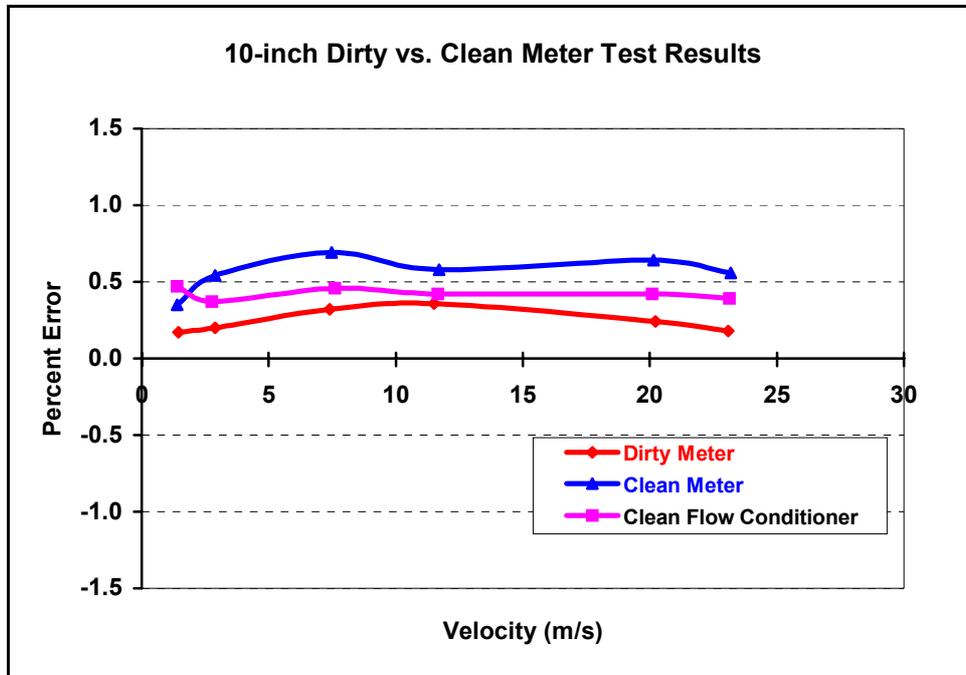
Figure 3 – 10-Inch “Dirty” and “Clean” Meter Results

Figure 3 shows three test results for this meter. Included are the “as found” with dirty meter and spools, the results after cleaning only the flow conditioner, and the results after cleaning the entire meter assembly was cleaned. No components were changed during these tests, and the meter’s configuration remained the same for all three calibrations. The meter was returned to Houston, disassembled and cleaned before the final testing was completed.

This meter was previously calibrated at another facility before installation. It was not practical to perform the dirty vs. clean meter testing at this same calibration lab. Thus, the meter factor was returned to the original value (1.0000) prior to testing. This was done to eliminate potential concern about any difference that might have been seen between the two labs and focus on the actual test results. There were no other changes other than the meter factor.

The FWME for the dirty results in Figure 2 is 0.9975. After cleaning only the flow conditioner the meter factor was 0.9959, and after cleaning the meter body, flow conditioner and all meter spools the FWME changed to 0.9939. This equates to an average change in meter performance of 0.16% when only the flow conditioner was cleaned, and 0.36% when the entire meter was cleaned. So, why does this meter’s performance go slower when dirty instead of faster?

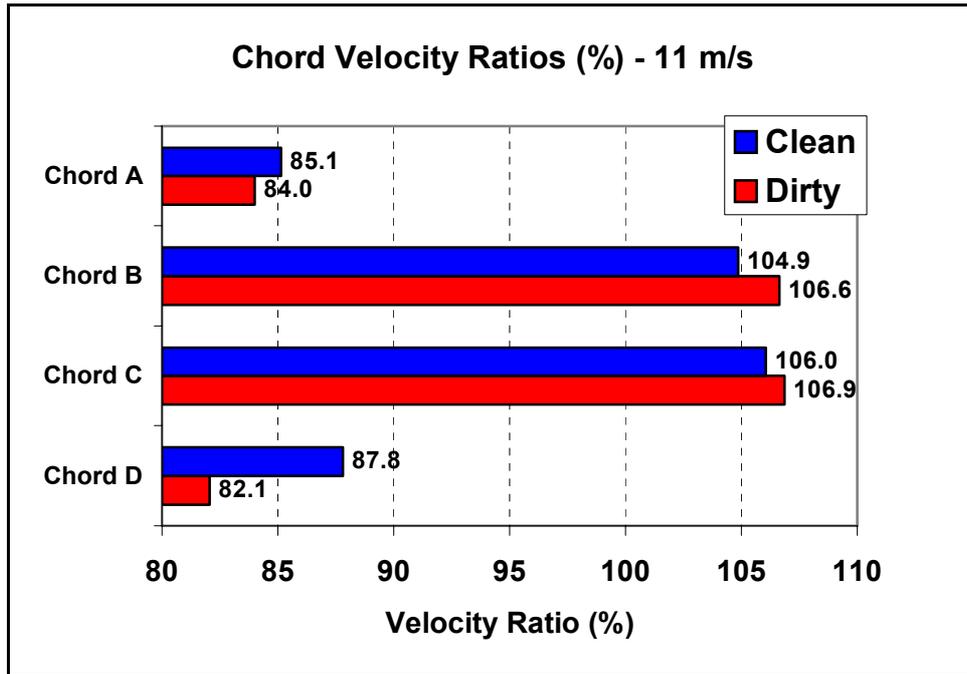
Figure 4 – Chord Ratios at 11 m/s

From the graph in Figure 4 it is clear the velocity profile has changed from the clean to dirty meter (red bar graphs are for dirty and blue for clean). The chord ratio profile remains virtually the same over the entire velocity range. Thus, it is not necessary to have a variety of gas velocities, or a prover system, in order to determine if the velocity profile has changed (from the original clean to dirty condition). Since the technician generally collects “start-up” information on the meter, the velocity profile analysis can be used to later determine if the meter is dirty during regularly scheduled inspections.

When looking at the chord ratios for B & C (the middle two chords) notice the difference between the clean and dirty meter. In both graphs the dirty velocity ratio is higher than the clean. The A & D chord ratios showed a bit more pronounced effect from dirty to clean, but in the opposite direction. Their readings were much lower when compared to the meter’s average velocity. The surface friction has clearly changed the velocity profile to be more pointed than when the meter was clean.

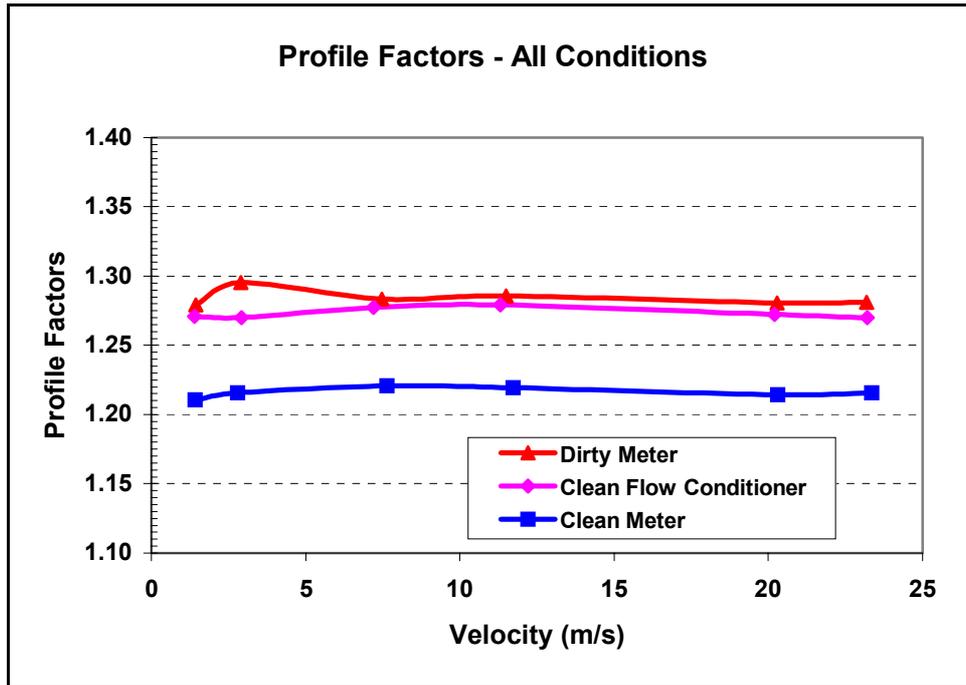
Figure 5 – Profile Factor for All Velocities

The profile factor technique in Figure 5 shows the dirty meter condition (in red) has a much higher value than the clean (the blue line) condition. In other words it has a more pointed velocity profile. It is also important to note that all three of the factors remained very constant, and linear, over the entire range of velocities. Thus, even if the profile factor from a previous inspection was obtained at a different velocity, it will be still be valid.

Notice the profile factor changed only slightly when the flow conditioner was cleaned (magenta color). It appears the majority of the profile effect was due to the upstream piping and perhaps the meter's internal coating.

Since the internal diameter was reduced when it was dirty, the accuracy affect should have been to over-register when dirty. However, since the opposite occurred, what can be the cause? Well, as can be seen from the above flow profile factor, there was a definite change. This profile change (from a flatter profile to a more pointed one when dirty) caused the meter to under-register more than the inside diameter (ID) reduction caused it to over-register. Thus, one effect somewhat cancelled out the other. The theory says that the chordal design should be insensitive to wall roughness effects [Ref 10]. However, the velocities derived from the 4 different chordal paths integrate over an area between the transducers probably contributing to the meter not following exactly the theory.

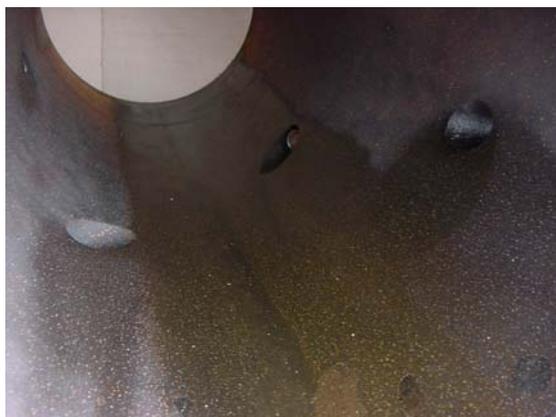
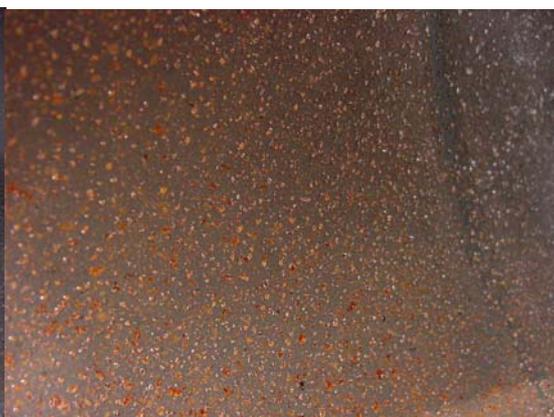
Picture 17 shows the interior of the meter coated with an oily substance. Picture 18 shows this coating has some texture to it and is merely not just a thin coating of oil. Unfortunately the thickness of the coating was not measured.

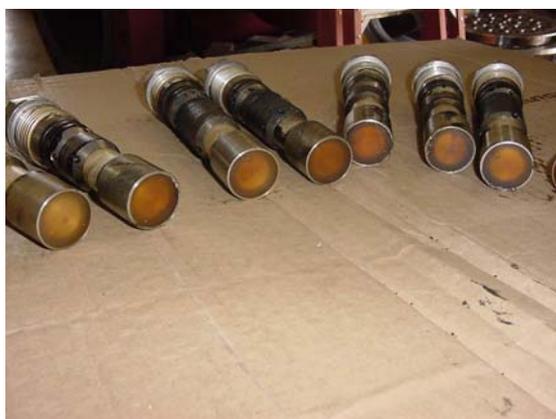
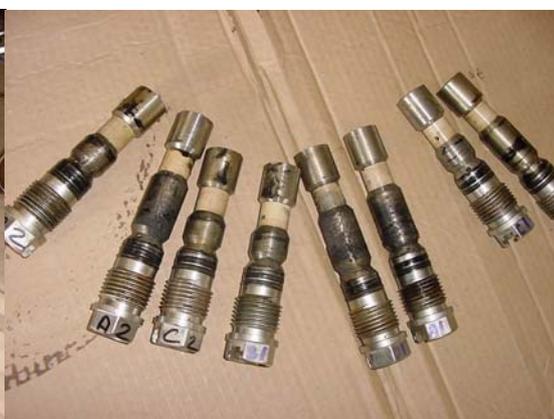
Picture 19 shows the transducer faces are clean. They're clean because they don't protrude beyond the meter wall. Thus, with this meter design, transducer buildup is virtually non-existent. As there was nothing coating the transducers, the gain and SOS were not impacted. This is important since a coating on the transducer faces will cause the meter to register faster than with no coating [Ref 9].

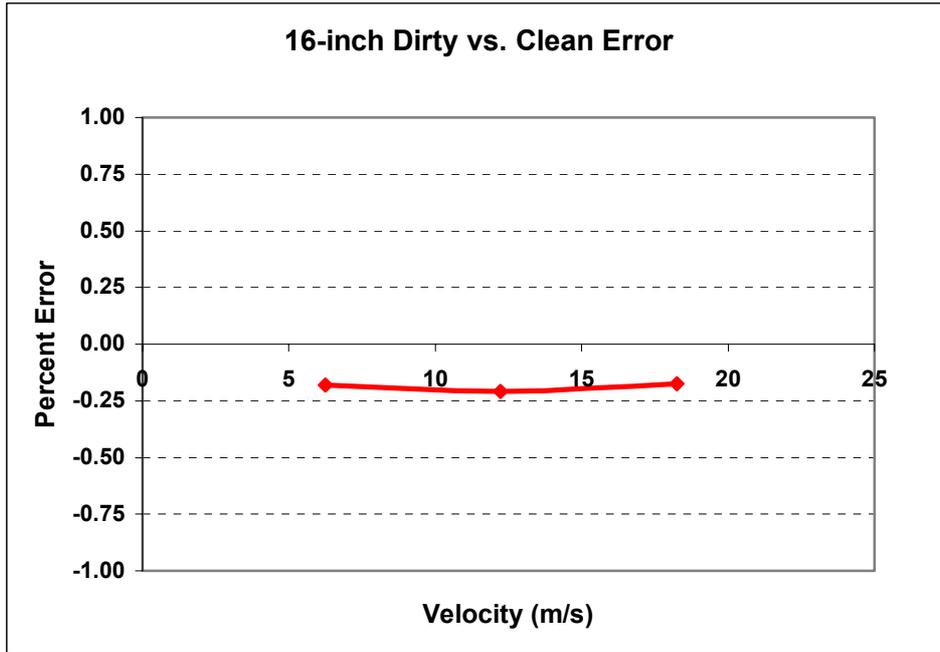
Figure 6 – 16-Inch Dirty vs. Clean Difference

Figure 6 shows the difference in meter error when it was dirty versus clean. That is, this meter registered slower by about 0.2% when dirty just as the 10-inch in Section 3.2 showed.

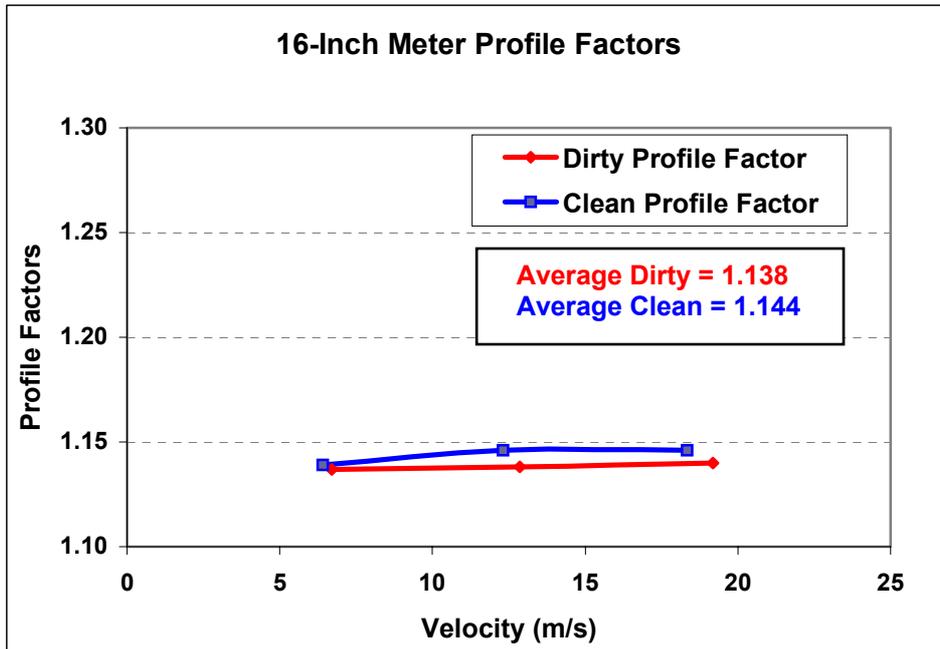
Figure 7 – 16-Inch Profile Factors

Figure 7 shows the profile factors, both dirty and clean, at the three calibration velocities. In this example there is virtually no difference in profile factor between dirty and clean, or at the different velocities. The 10-inch meter in Section 3.2 showed a significant change in profile factor (0.06). This change did not occur for the 16-inch as the difference was only 0.006.

It takes several diameters of piping to establish a flow profile. Since the upstream piping was clean, simply cleaning the meter essentially did not change the velocity profile as seen by the

meter. From this it might be concluded that it is important to calibrate the USM with the upstream piping if the true performance of the meter in the field is to be realized.

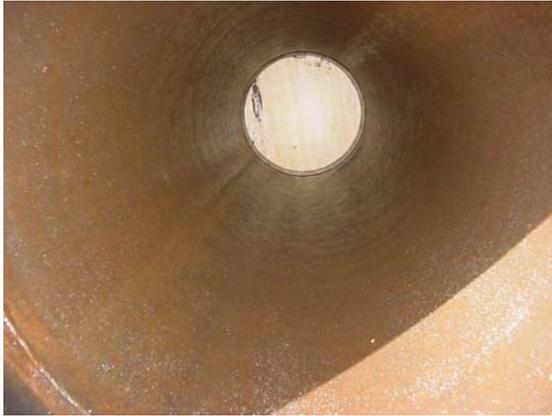
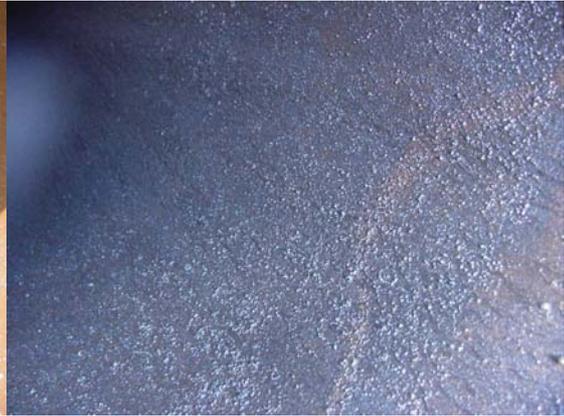
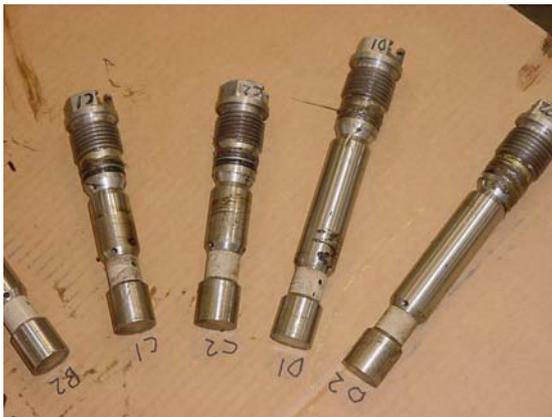
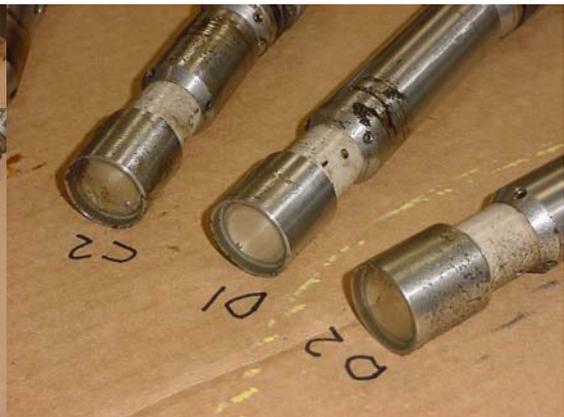
As Picture 21 shows this meter had some contamination throughout the meter body. Picture 22 shows that the coating was more than just an oily film as it had a very rough texture. Picture 23 shows contamination exists on the transducer housings, but in Picture 24 there is again no contamination on the face of the transducer.

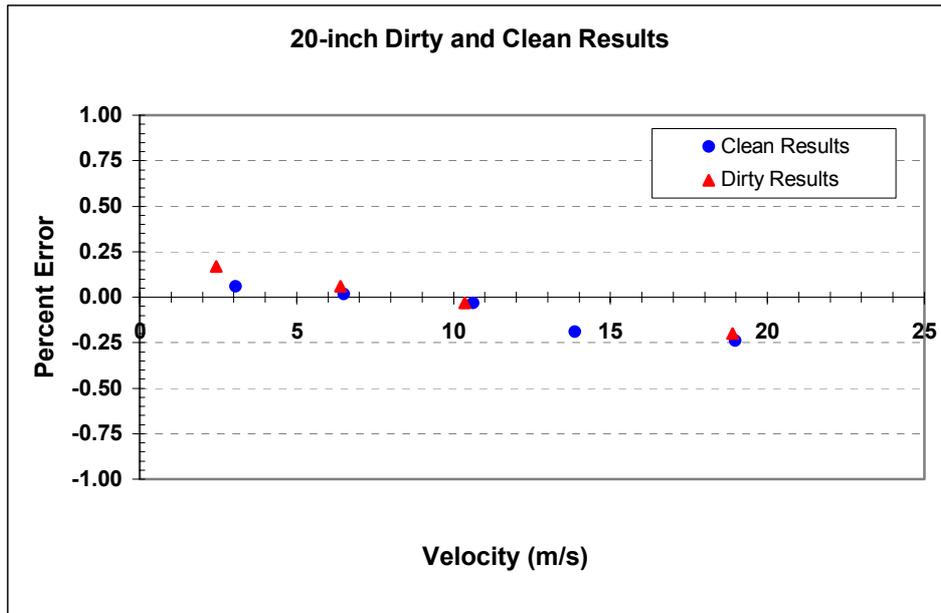
Figure 8 – Error Results from 20-Inch Meter

The results of the calibration show virtually no difference between the dirty and clean results. The average difference in error for the data points is about 0.05%. This is below the stated repeatability of the facility and the meter. The extra data point at 14 m/s was taken after cleaning as this customer elected to re-calibrate before returning the meter to service. Thus, one might conclude there was no effect on meter accuracy.

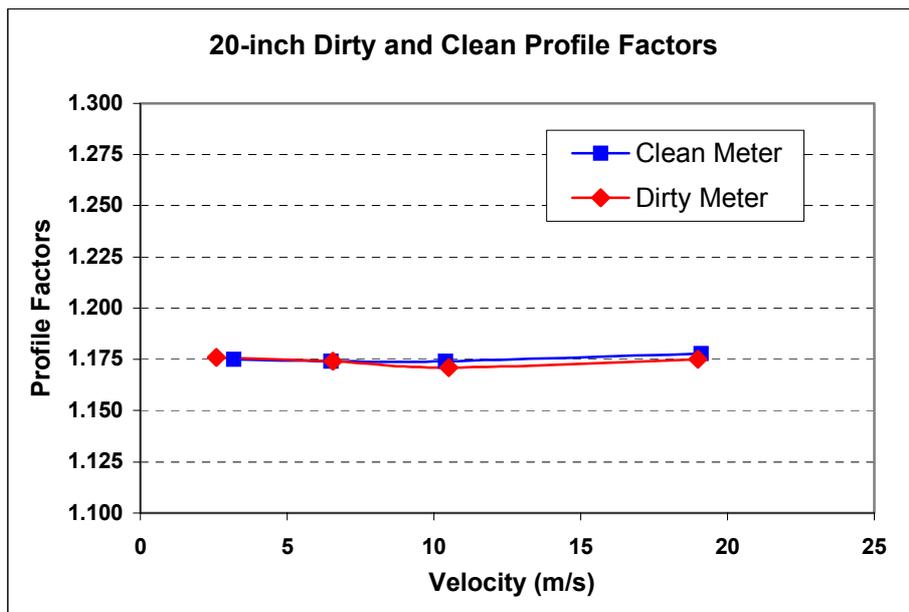
Figure 9– Profile Factor for 20-Inch Meter

Graph 9 shows the profile factor for both conditions (dirty and clean). Since the error from dirty to clean was virtually zero, it isn't too surprising to see that both profile factors are virtually identical. The upstream coating inside the piping had very little impact on the profile, and thus little impact on the meter. Probably the reason the coating had little impact was due the larger diameter. The same amount of buildup on a larger meter appears to cause less shift in meter performance.
