**Diagnosis and Mitigation of Contamination Build-up  
in Multipath Liquid Ultrasonic Meters  
on the Danish Oil Pipe**

**Dr Gregor J Brown, Cameron  
Lars Bach, DONG Oil Pipe A/S**

**34<sup>th</sup> International North Sea Flow Measurement Workshop  
25-28 October 2016**

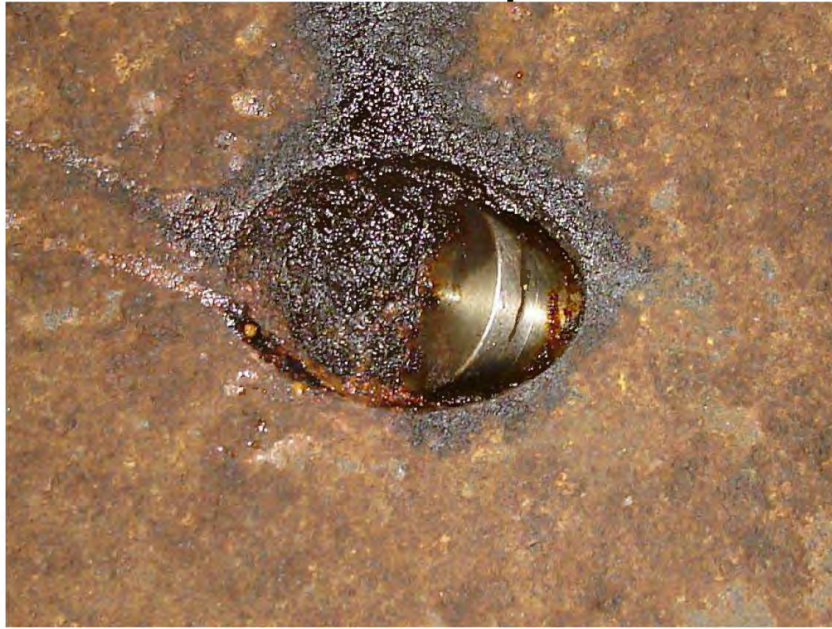
One of the two 2-path meters, the one removed from the line most recently, appeared to have been partly cleaned. The partly cleaned 2-path meter was corroded internally (being made of carbon steel) but was largely free of deposition in the bore. It did however have sticky deposits in the transducer housing cavities, partially covering the face of the transducer housings, as shown in the photograph of Figure 7.

**Fig. 7 - Deposition in the transducer cavity of a partially cleaned 2-path meter**

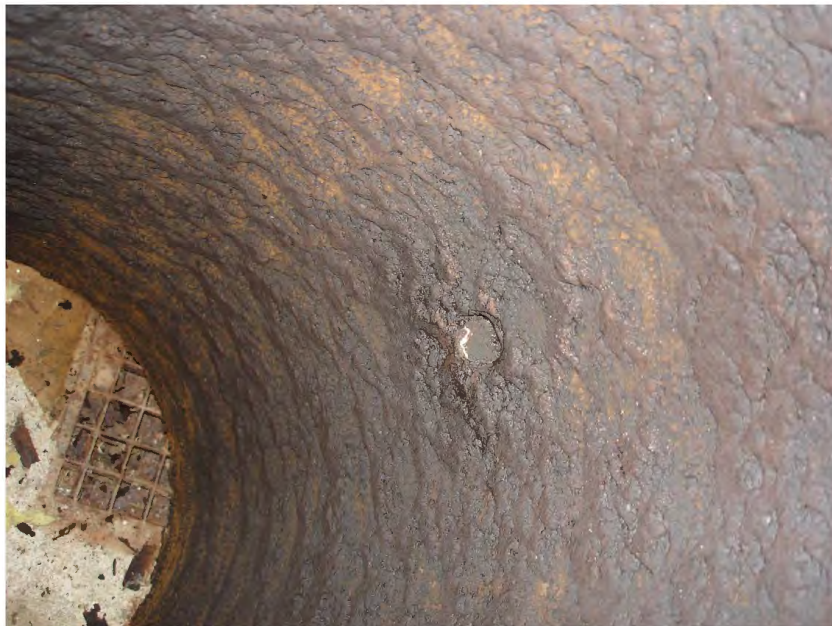
The second 2-path meter had been removed from service some 10 months earlier and did not appear to have been cleaned at all. It was found in a more severe state of contamination. As well as having deposits in the transducer housing cavities, the internal surface of the meter was covered in a heavy, wavy deposition that had dried to a hard crust that was a few millimetres thick in places. Photographs of the interior of the second 2-path meter are shown in Figures 8, 9 and 10.

**Fig. 8 - Interior of a contaminated 2-path meter (transducer housing in centre of photograph)**

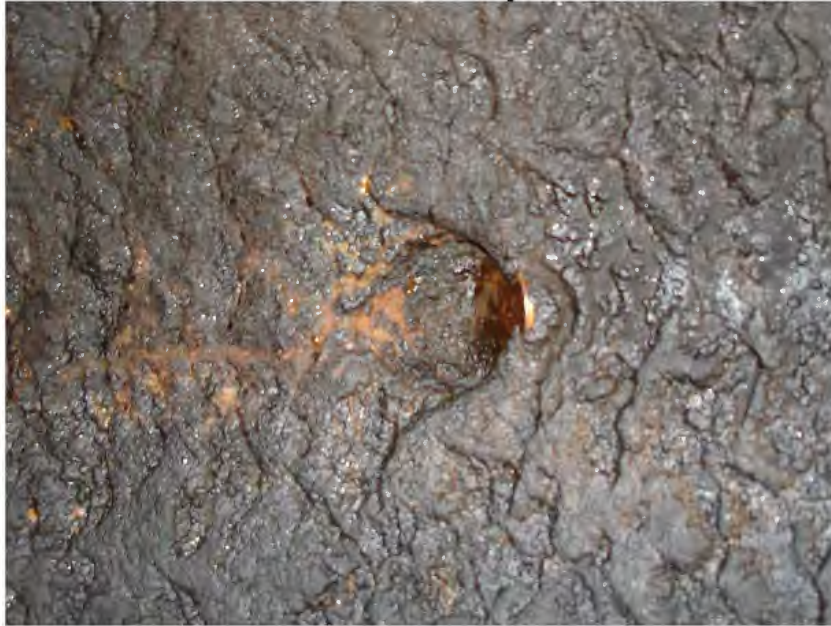
Fig. 9 - Interior of a contaminated 2-path meter (close up of a transducer housing cavity)

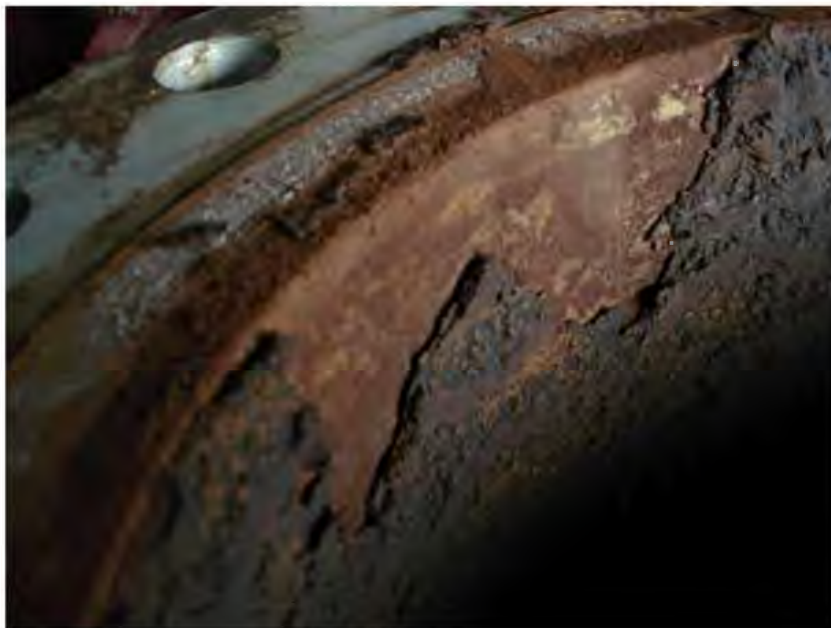
Fig. 10 - Contaminated 2-path meter showing the thickness of the deposition (which had solidified/dried to a 'crust' during 10 months in storage)

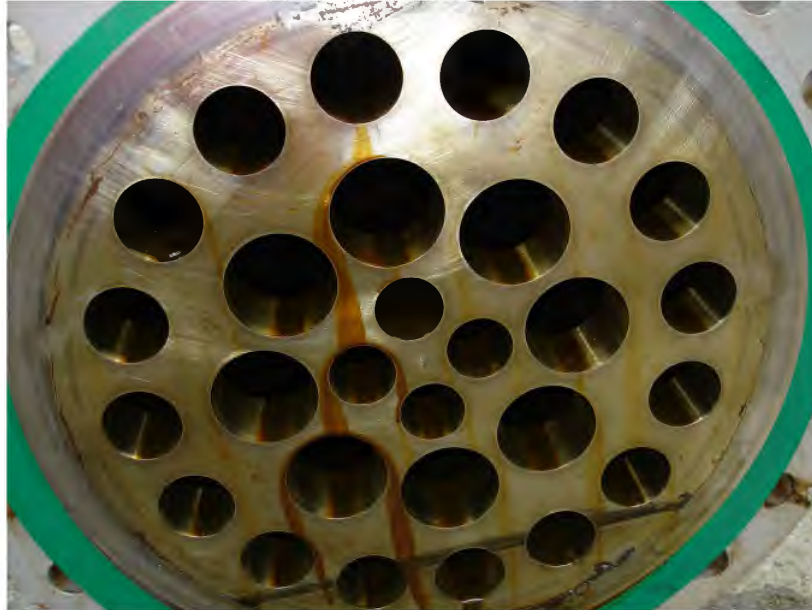
Figure 11 shows the Spearman flow conditioner. The Spearman plate was found to be in good condition with no deposition on its surfaces and no upstream blockage or debris trapped in the holes.

Fig. 11 - Spearman conditioner after 11 months in service

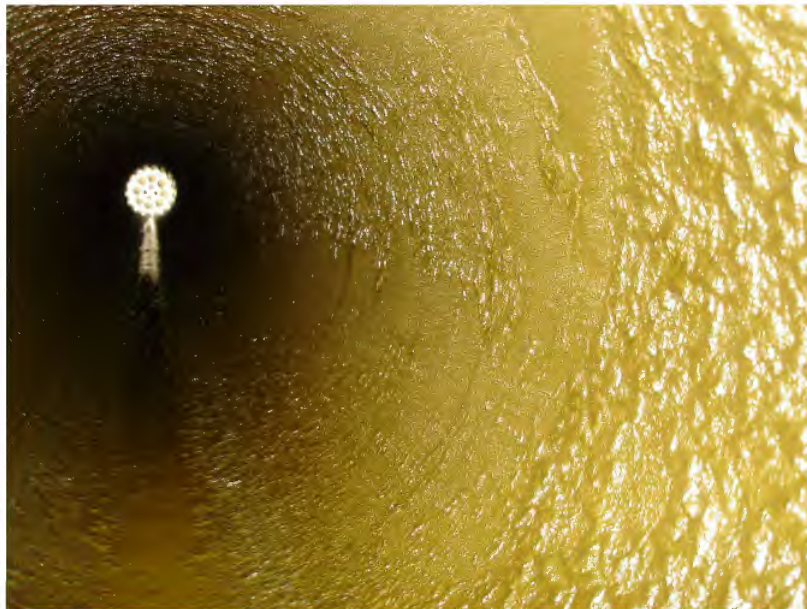
Figure 12 shows the interior of the upstream pipe. It was observed that this carbon steel pipe had corrosion and deposition broadly similar to the 2-path meter body that had not been cleaned.

Fig. 12 - Photograph showing deposition in the upstream meter tube

Following the inspection, the upstream pipe was cleaned first and then the meter was returned to service. The cleaning of the upstream pipe altered the velocity profile and brought Meter 1 and Meter 2 into slightly better agreement but only by about 0.1%. In other words, although the actual velocity profile was altered, it did not have a very significant effect on the calibration of the meter. This finding is in line with expectations given knowledge of the robustness of the chordal integration technique used in these meters and corroborated by the linearity of the meters demonstrated at calibration.

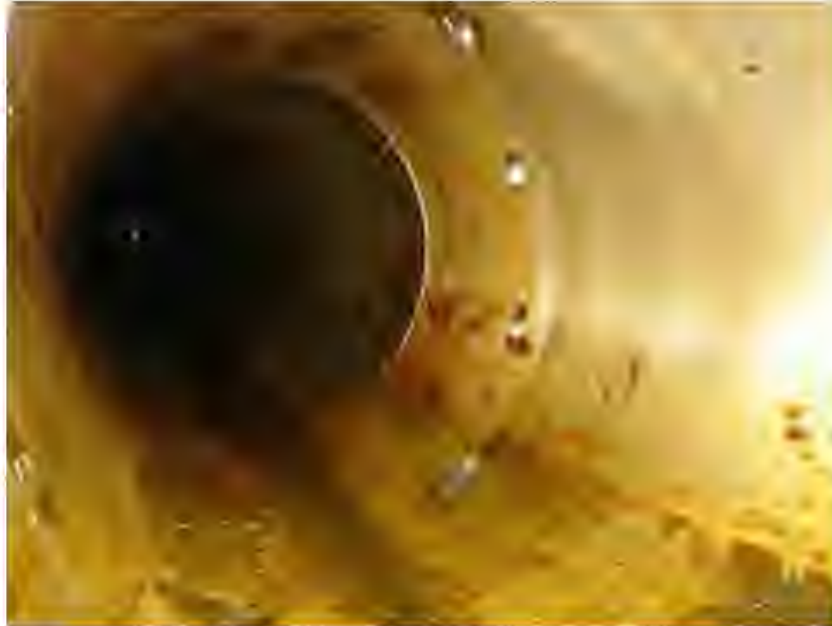
When the bore of the 4-path stainless steel ultrasonic meter body was inspected it was found that it was not as badly contaminated as the bore of the carbon steel upstream pipe (or the bore of the carbon steel 2-path meter bodies), as shown in Figure 13.

**Fig. 13 - Photograph showing the bore of the stainless steel 4-path meter after 11 months in service (Meter 1)**

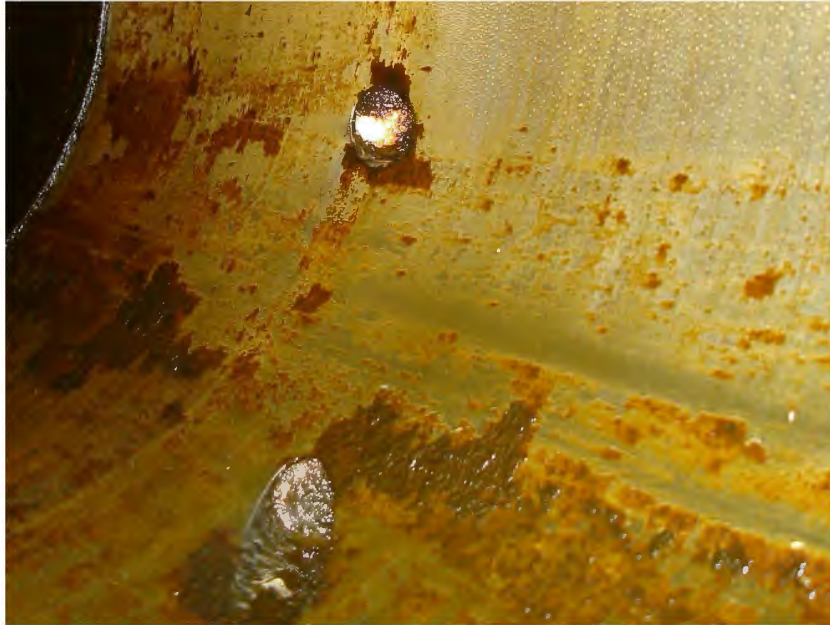
On closer inspection of the interior of the meter, there was clear evidence of deposition in the transducer housing cavities, particularly those that were facing downstream. This can be seen by comparing Figure 14 which shows two transducer cavities facing upstream and Figure 15 which shows a transducer cavity that is facing downstream. In every case, the deposition was worse in the cavities facing downstream than those facing upstream, suggesting that the flow was having a beneficial 'scouring' effect on the cavities that face into the flow.

Fig. 14 - Photograph showing transducer housing cavities facing upstream

The next step was to take Meter 1 out of service again and clean it. When this had been completed the diagnostic indicators such as normalised velocity of sound (VOS) and Gain came back into very close agreement with the commissioning data (see Figures 16 and 17). Cleaning Meter 1 had the effect of reducing the difference between the two meters from ~0.9 % to ~0.2 %.

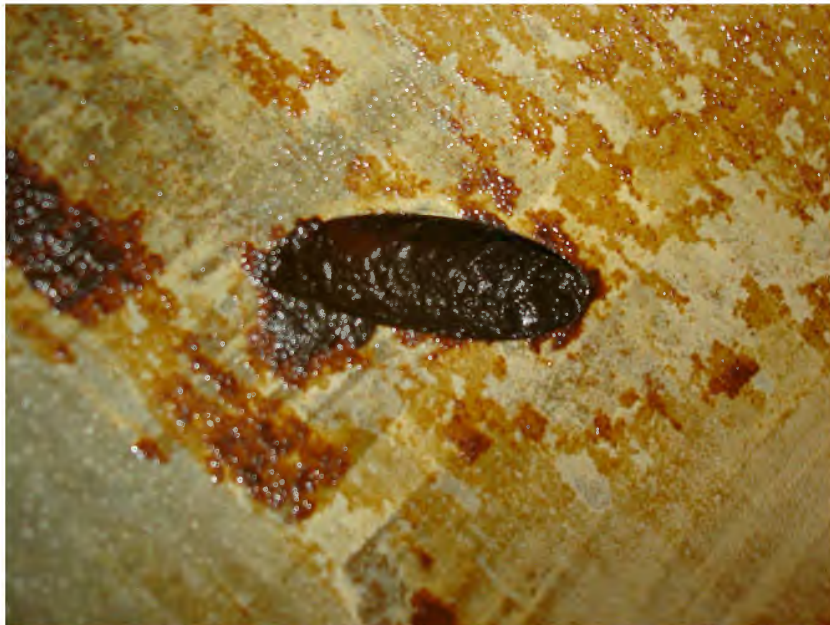
Fig. 15 - Photograph showing a transducer housing cavity facing downstream

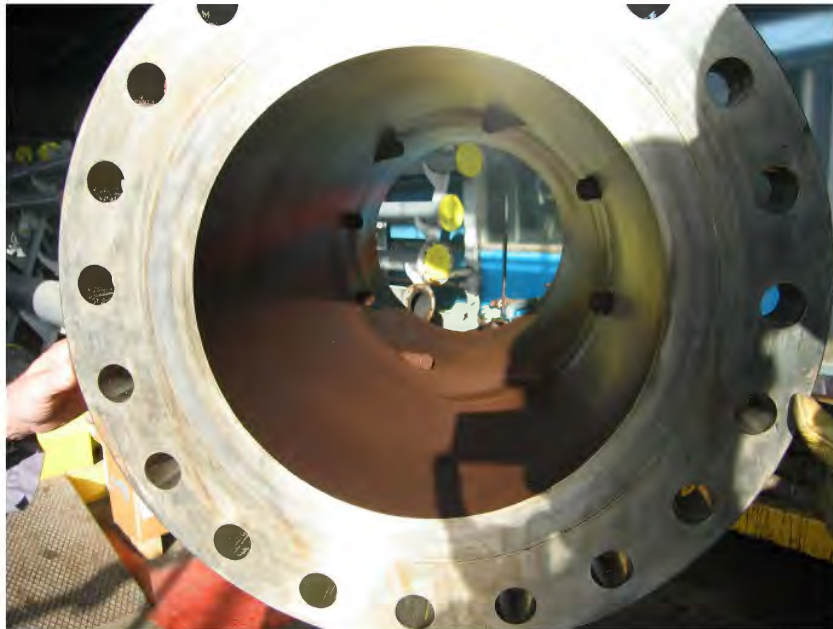
Fig. 21 - Meter 1 with protruding transducer housings and internal coating, photographed prior to calibration

Meter 1 was returned to Cameron for modification. First the transducer housings were removed and replaced with longer housings such that the face of the housing would protrude fully into the flow. Then the meter body was sent to be coated internally using a proprietary fluoropolymer coating formulation and application method.

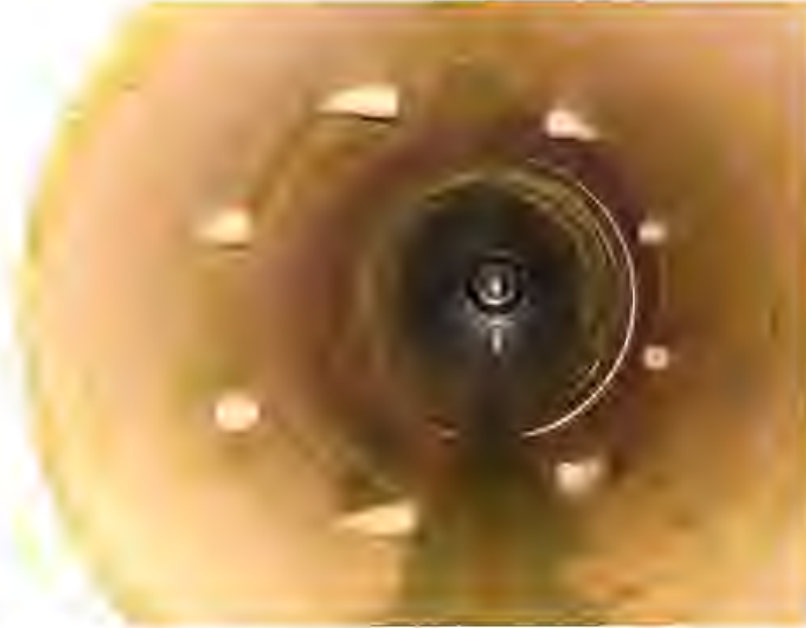
Based on diagnostic analysis and an internal inspection of the meter after 9 months in service (see the photograph show in Figure 26), it was clear that the modified meter was no longer suffering from the problem of deposition in front of the transducer housings. However it was also clear that the decision to protrude the transducer housings had resulted in a different problem. As a result of protruding the transducer housings, the meter design did not respond appropriately to changes in the boundary layer of the flow. In other words, protruding the transducer housings had impaired the ability of the meter to properly integrate the velocity profile. This, in combination with the fact that DRA was being used, made it impossible for the meter to accommodate the changes in flow profile in the area close to the pipe wall, a problem that the standard, unmodified meter did not have.

**Fig. 26 - Inspection of the meter with protruding transducer housings and internal coating, after 9 months in service**

Having discussed the conclusions above with the customer a decision was reached to return Meter 2 to Cameron and have it coated internally, but this time without also taking the step of protruding the transducers.

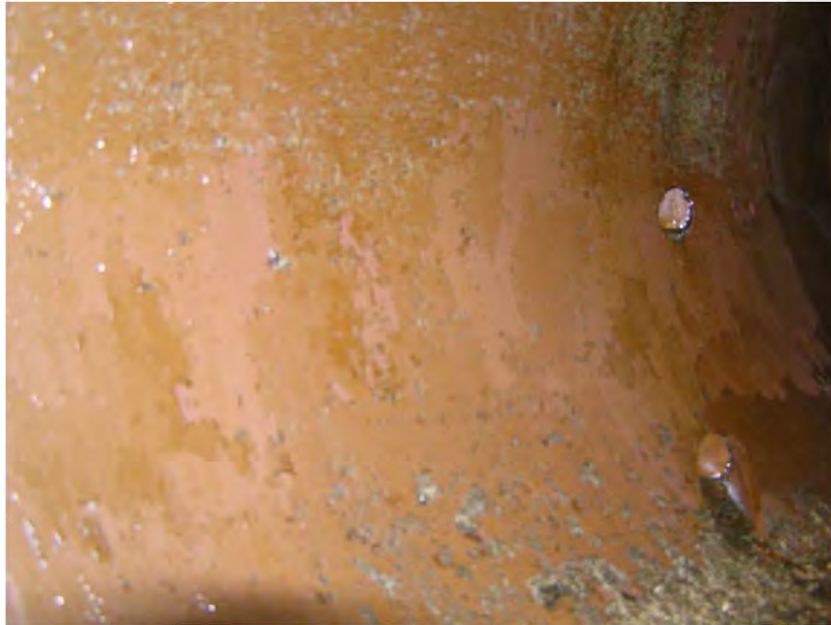
Following the evaluation Meter 2 after modification (coated and with transducer housings recessed as normal), Meter 1 was returned to the factory and made the same as Meter 2. Subsequent diagnostic checks and periodic inspections have shown that the meters are not completely free from the effects of contamination. However, the coating applied to the meters has substantially reduced the build-up problem. Figures 30 and 31 show photographs of the interior of Meter 2 after it had been coated and had been in service for approximately 10 months without cleaning. Although the interior surfaces are not free from contamination, it was observed that the contaminants have greater difficulty in adhering to the coated surface than they did with stainless steel, and in some places it appeared that the flow had stripped the contaminants off of the pipe wall, leaving the coated surface clean. Of particular importance it was observed that the problem of contamination build-up forming in the cavities of the upstream transducer housings was significantly reduced, as can be observed by comparing Figure 31 with that of Figure 15, which both show the deeper cavities of the outside paths. In the case of the uncoated meter the deposition covers the whole of the interior of the cavity and the face of the housing. With the coated meter there is much less deposition and it appears not to have consolidated in the same way as for the uncoated meter, suggesting the coating results in a 'self-cleaning' effect.

Fig. 30 - Photograph showing the coated meter with transducer housing cavities facing upstream

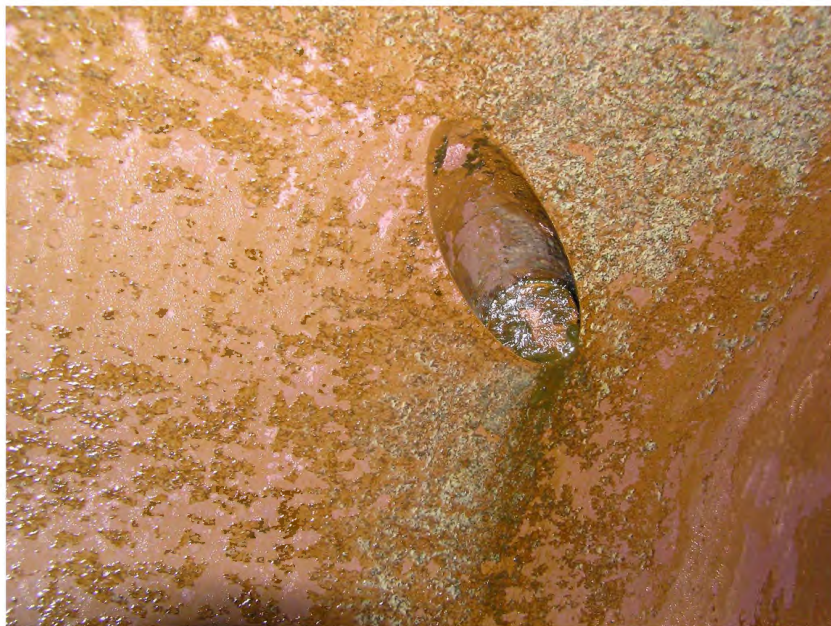
Fig. 31 - Photograph showing a the coated meter with a transducer housing cavity facing downstream
