North Sea Flow Measurement Workshop 22-24 October 2018

Technical Paper

Metering Skid Life-Extension Challenges Njord Field Rejuvenation

Christine Kristoffersen, Equinor ASA
Jørn Heibø, Process Control AS
Mohammad Hajiarab, Equinor ASA

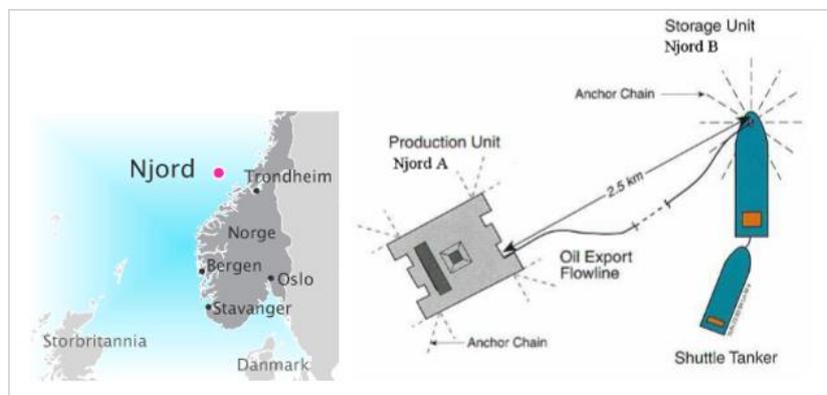
Fig. 1 - Njord Field Location and Layout

The field was developed with Njord Alpha as the Floating Production Unit (FPU) and Njord Bravo as the Floating Storage Unit (FSU). The FPU is an integrated floating steel platform with drilling and processing facilities as well as living quarters. The stabilised crude oil is transferred from FPU to FSU and exported to market via shuttle tanker from Njord Bravo FSU.

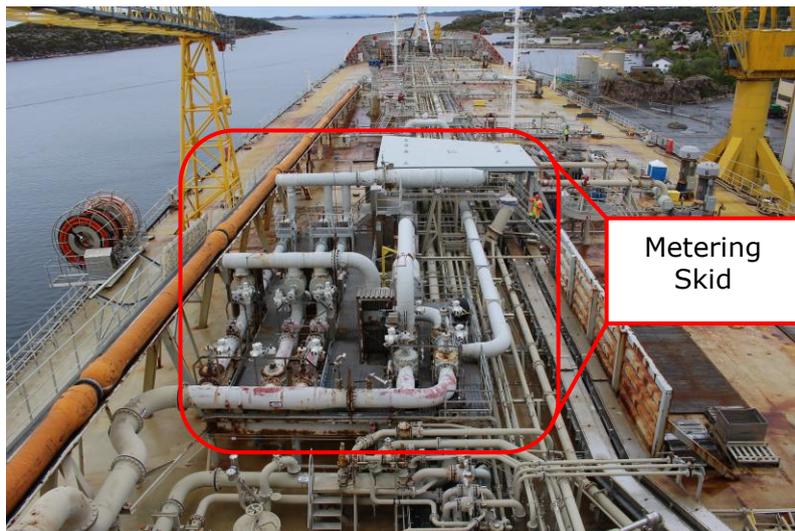
Fig. 2 – Original Metering Skid Onboard Njord Bravo FSU in Kristiansund

As part of preparations and considerations for decision basis, a preliminary in-situ refurbishment scoping was performed on the metering skid while the vessel was on quayside in Kristiansund.

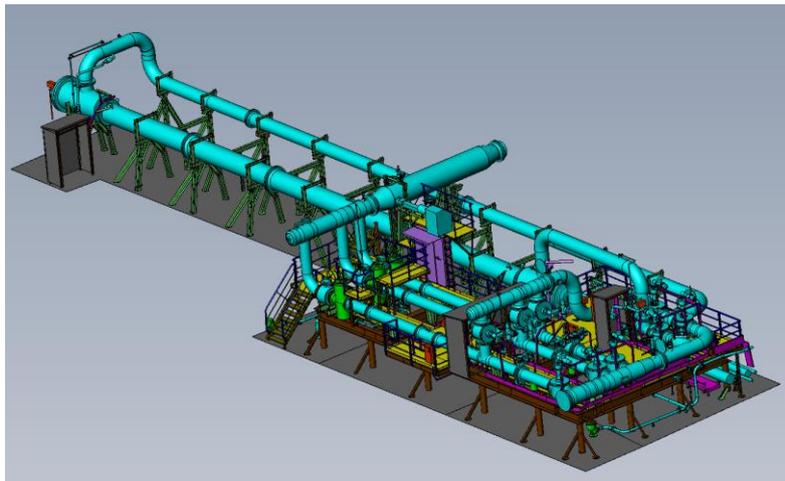
Fig. 3 - Njord Bravo Original Metering Skid 3D model

Before conducting metering skid dismantling, a high-resolution laser scan of the skid was performed to generate a detailed 3D model. The model was then used for dismantling planning as well as assembly and installation later on during hook up.

Availability of such detailed model provided a reference to ensure the refurbished skid is within dimensional tolerances of the original skid and final installation onboard Njord Bravo can be achieved with minimum disturbance to the original hook-up points on the vessel.

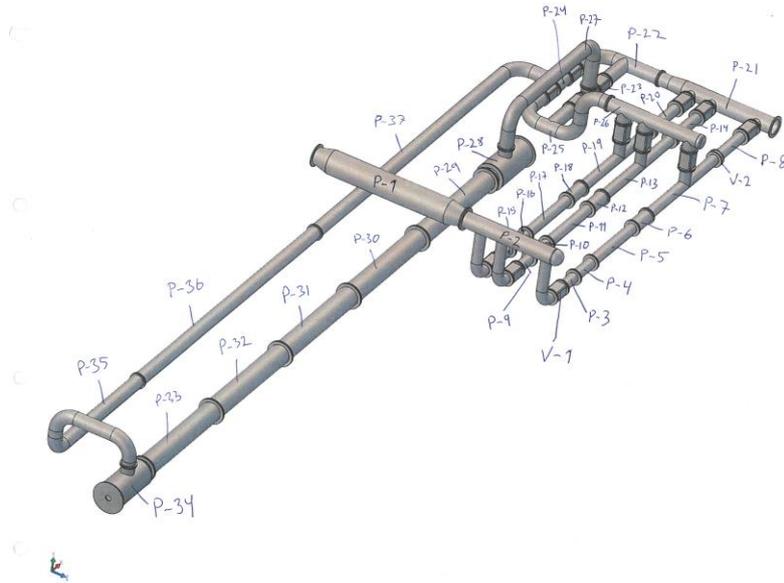
Fig. 4 – Internal Tagging of Original Metering Skid Pipe Sections

In order to achieve this goal, main pipe and valve pieces within the metering skid were assigned with an individual tag. Internal tagging of metering skid pipe sections is illustrated in Fig. 4 below.

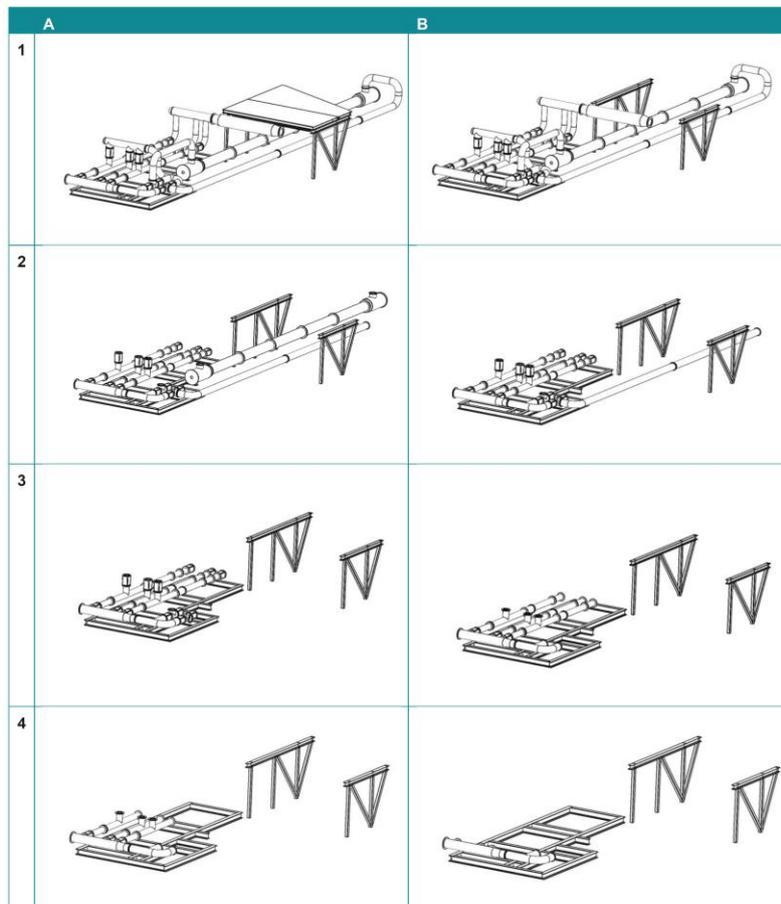
Fig. 5 – Metering Skid Dismantling Sequence

Following internal tagging of the metering skid, a step by step dismantling sequence was devised, See Fig. 5.

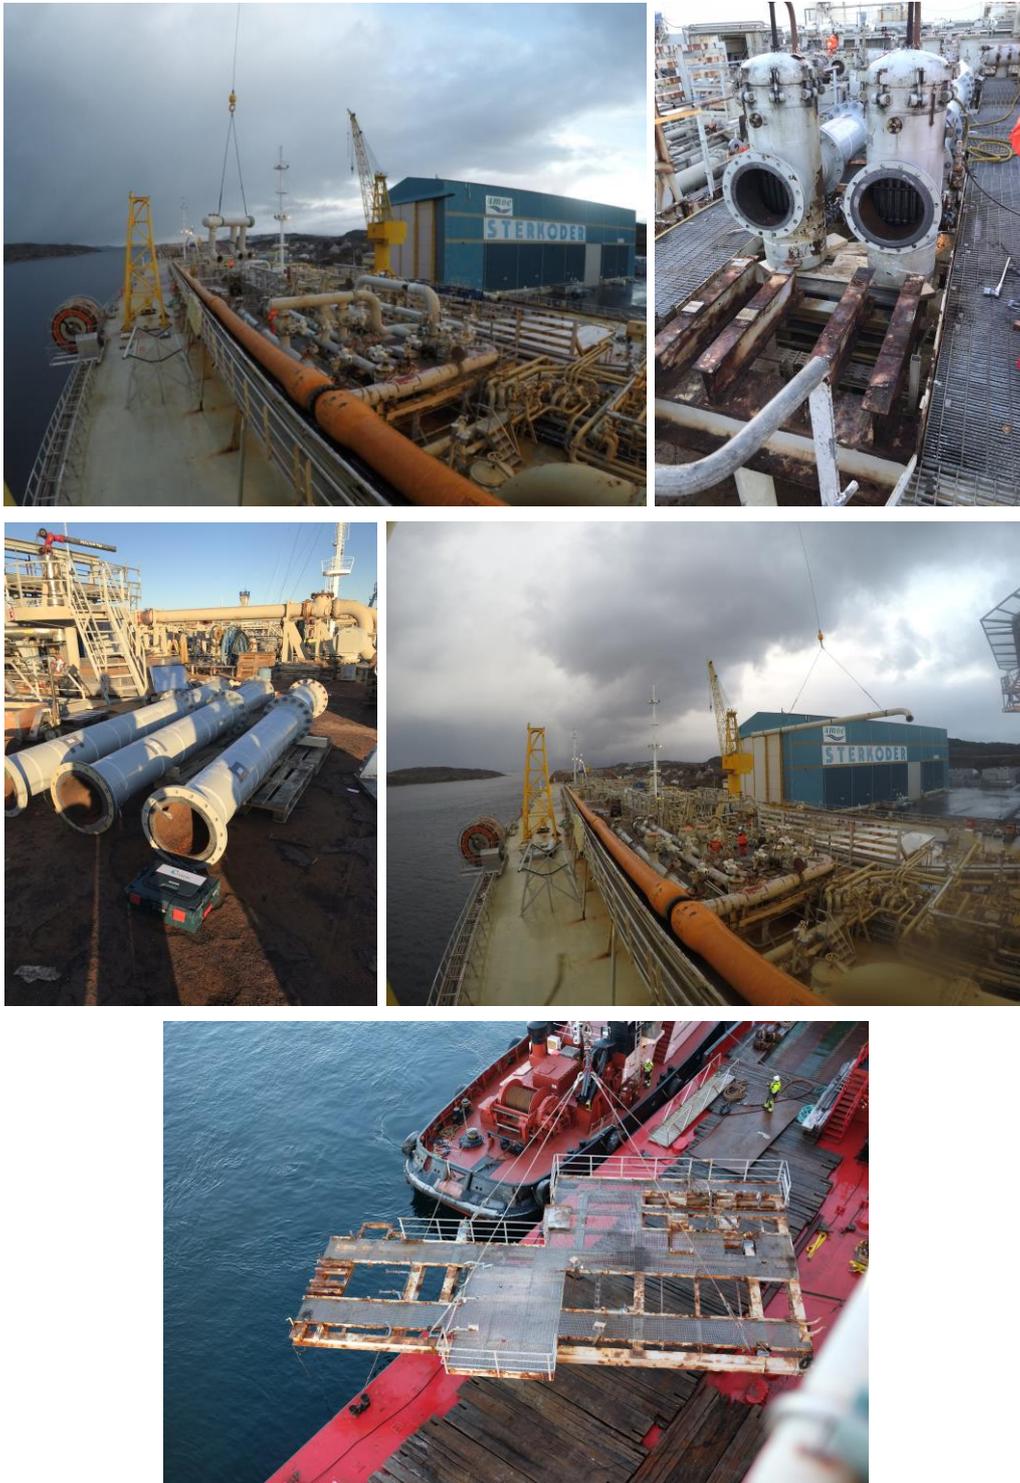
Fig. 6: Piece-by-Piece Dismantling of the Metering Skid

Dismantling execution was conducted following a detailed dismantling preparation and planning. The onboard offshore crane was recertified and used for piece-by-piece removal of the metering skid components from Njord Bravo to the quayside.

Fig. 6 shows snapshots of dismantling execution from removal of pipe sections to final removal of the metering skid structural frame.

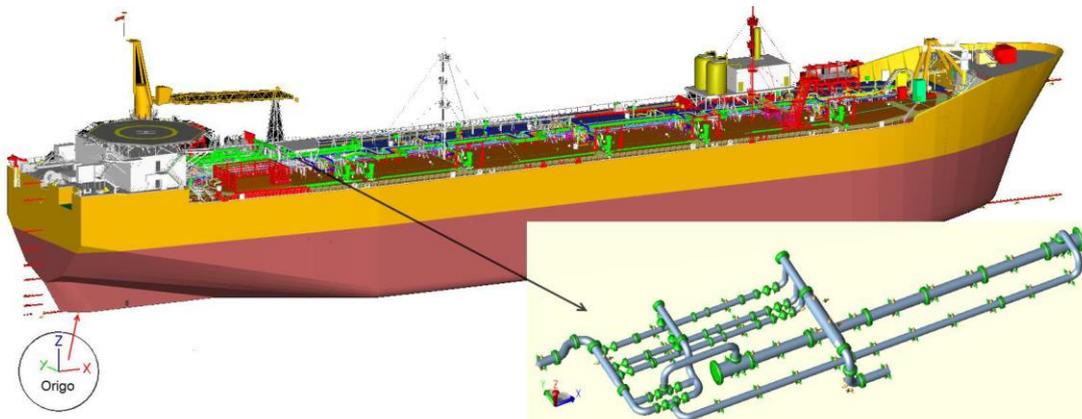
Fig. 7 – Piping Stress Analysis of the Skid as part of FSU Offloading System

Further to the above, piping stress and fatigue analysis of the metering skid was performed as part of the overall FSU offloading system, See Fig. 7.

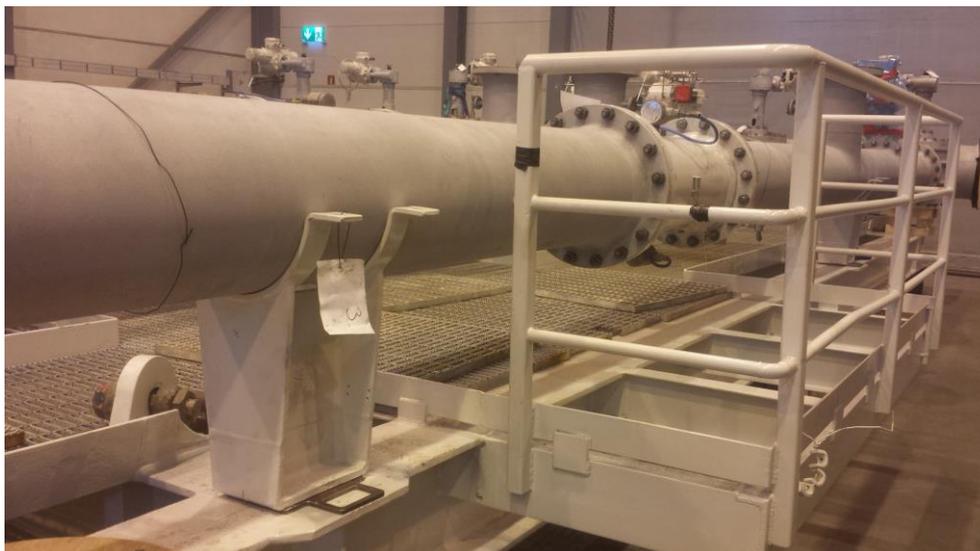
Fig. 8 – Optimised Pipe Support with Insert Plate (to be replaced with Teflon)

The piping stress analysis resulted in design improvements of some of the pipe supports, ensuring lessons learnt from past 20 years of operation are implemented in the refurbished supports, including use of Teflon plates between some of the supports and the main frame and modification of the support locking arrangement to ensure correct behaviour of the support during operation with minimum erosion damage to the frame, See Fig. 8.

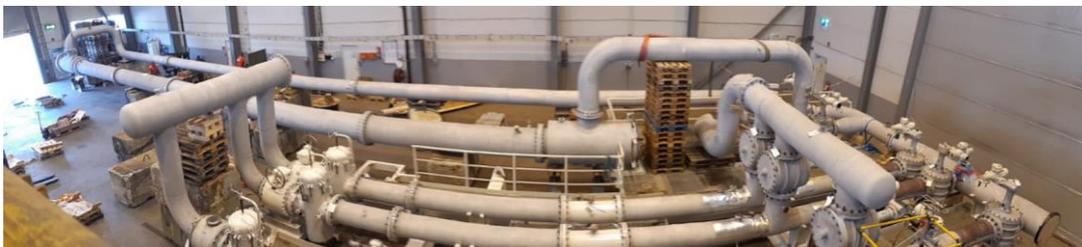
Fig. 9 – Re-assembly of the Refurbished Metering Skid

Re-assembly of the metering skid was conducted following refurbishment and reconstruction of the metering skid components, See Fig. 9.

Activities such as alignment of spools with frame, adjustment of pipe supports, bolt tensioning and flange management, introduced their own specific challenges to the re-assembly process.
