# **Experience with Installation of Ultrasonic Gas Flow Meters under severe conditions**

**North Sea Flow Measurement Workshop**  
October 22-25, 2001 Kristiansand, Norway

**Harald Denstad**  
**Skule E. Smørgrav**

**Statoil**  
**FMC Kongsberg Metering AS**

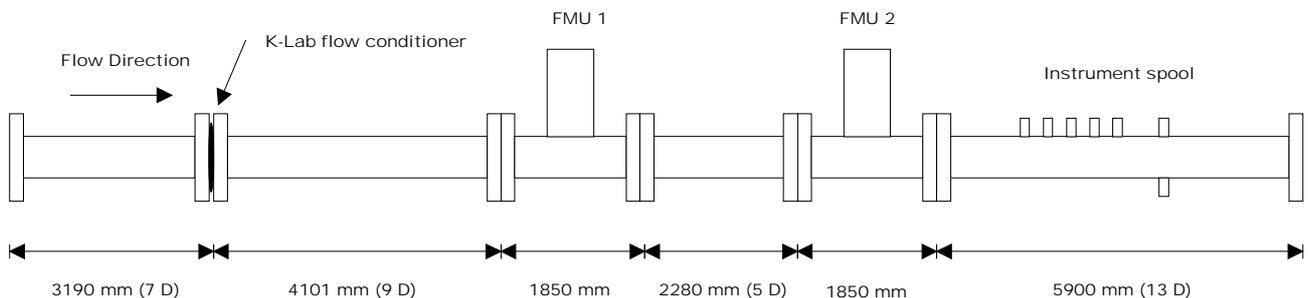
As can be seen in figure 1 below, the two FMU 700s on Åsgard B are installed in series with 9D straight upstream pipe to the flow conditioner and an additional 7D between the flow conditioner and the upstream 90° bend. Downstream meter 1 is a 5D section before meter 2 and then a 13D section containing dual pressure and temperature outlets as well as an annubar check meter.

**Figure 1: Åsgard B metering section**

Prior to installation the entire metering skid, as shown in figure 1 including flow computers, pressure transmitters, temperature transmitters and the annubar, was tested at K-Lab with different pressure and temperature combinations. And it was after that sent to Advantica, the former BG Technology calibration facility in Bishop Auckland, England, for flow calibration.

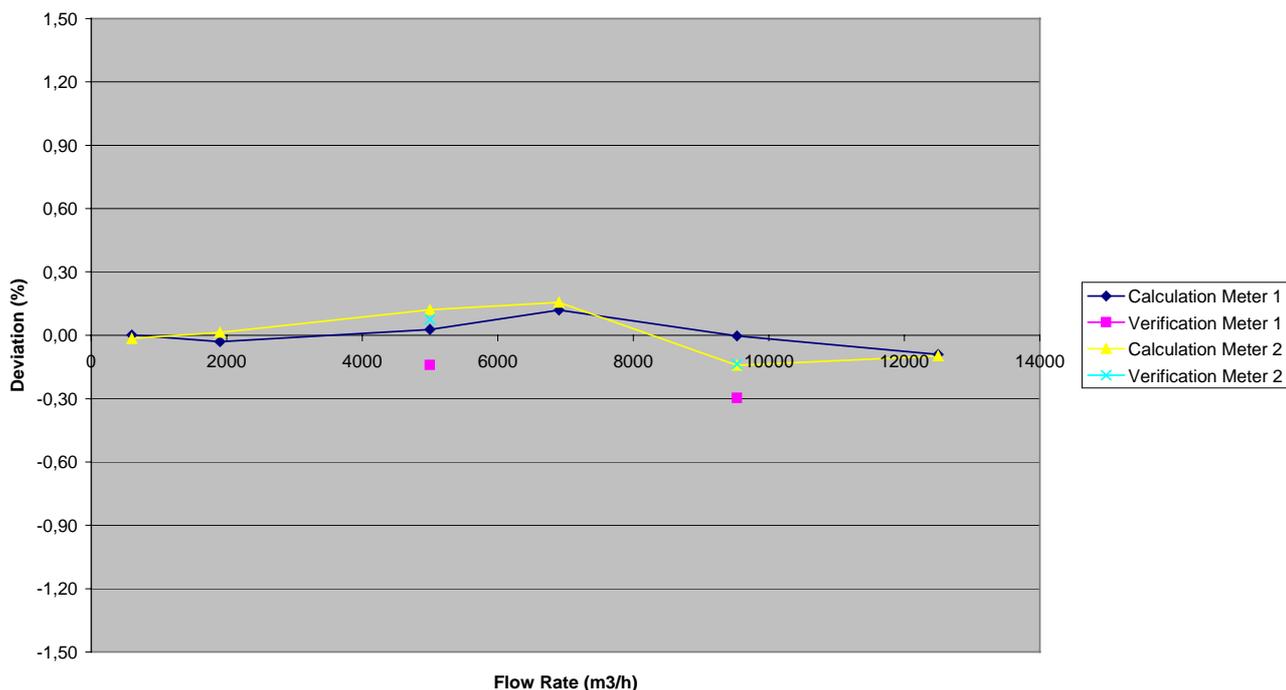
No noise or other problems were observed during the flow calibrations. The results from the flow calibrations with calibration factors implemented is shown in figure 2 below.

Figure 2: Åsgard B Flow Calibration

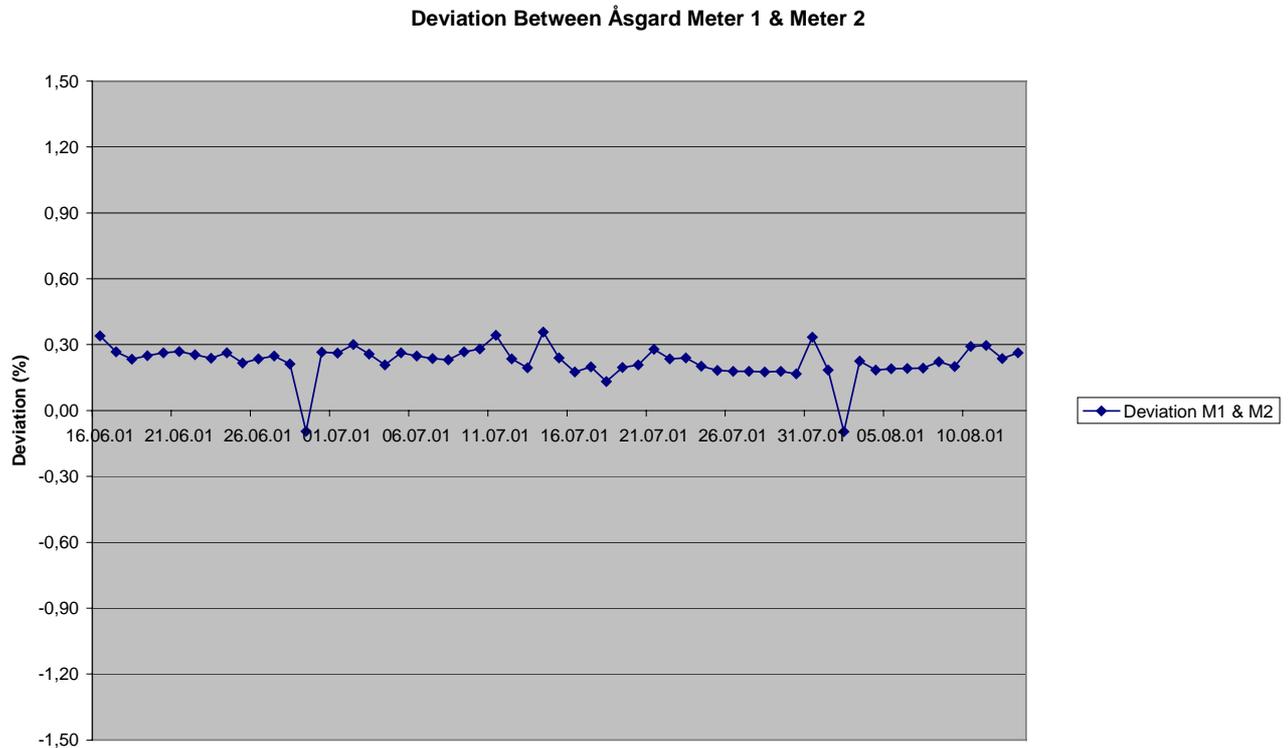
The succeeding 2 months from mid June to mid August the meters were in operation with no problems and with an average internal deviation of about 0.22 %.

Figure 3 shows the deviation between the two FMU 700s in the period from June to August 2001.

**Figure 3: Deviation between Åsgard B meter 1 and meter 2**

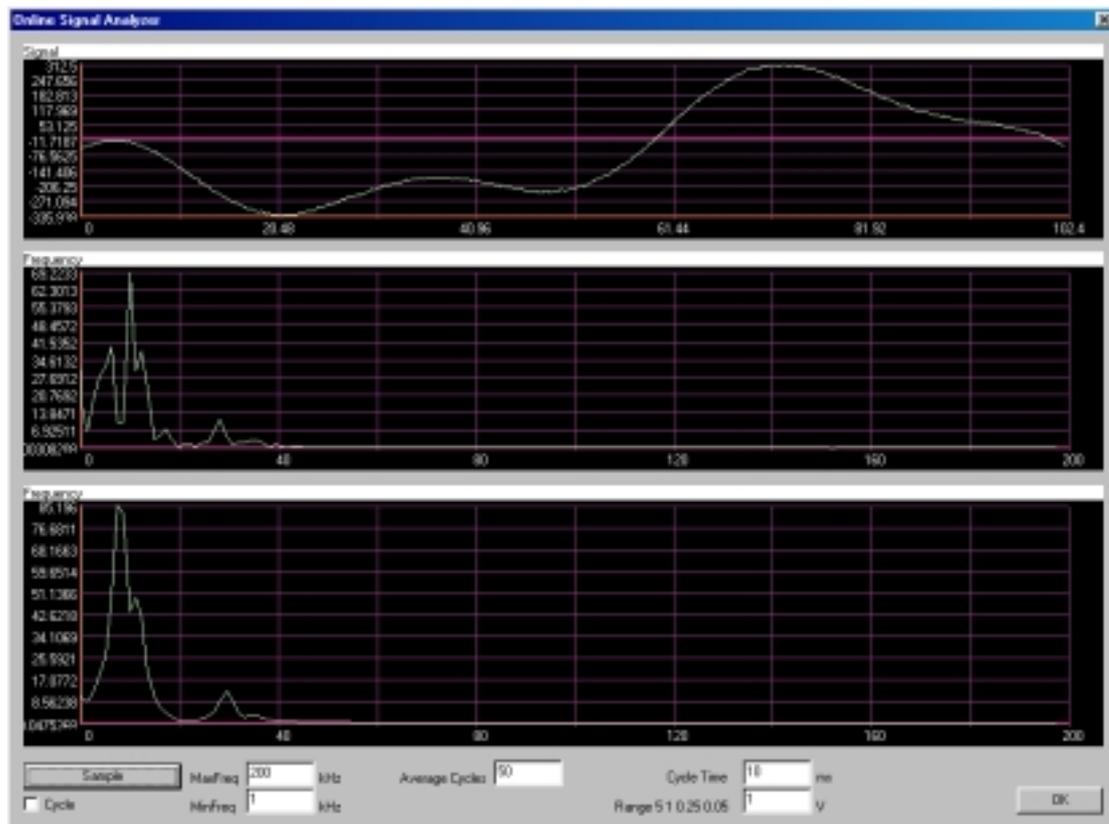
From the measurements done 17.10.00 with one of these clamp-on transducers at Åsgard B, it was found that the strongest noise was at 9 kHz and that it was propagating through the construction which the pipe with the two FMU 700 meters was resting on. Noise with this frequency can propagate over very long distances, especially in steel.

Figure 4 below show the frequency spectrum measured with the external clamp-on transducers. The Frequency scale is 0 – 200 kHz.

**Figure 4: Frequency spectrum with external clamp-on transducers, 0-200 kHz.**

To get an impression of how the sensitivity of the clamp-on transducers affects the result seen in the snapshots of figures 4 and 5, one must look at the calibration curve of these transducers. At 30 kHz the sensitivity of the clamp-on transducer is  $-60$  dB. At 70 kHz this value is  $-48$  dB and at 160 kHz the value is  $-22$  dB. So when the noise at 70 kHz and the signal at 160 kHz are not evident, this tells us how strong the noise at 9 kHz is.

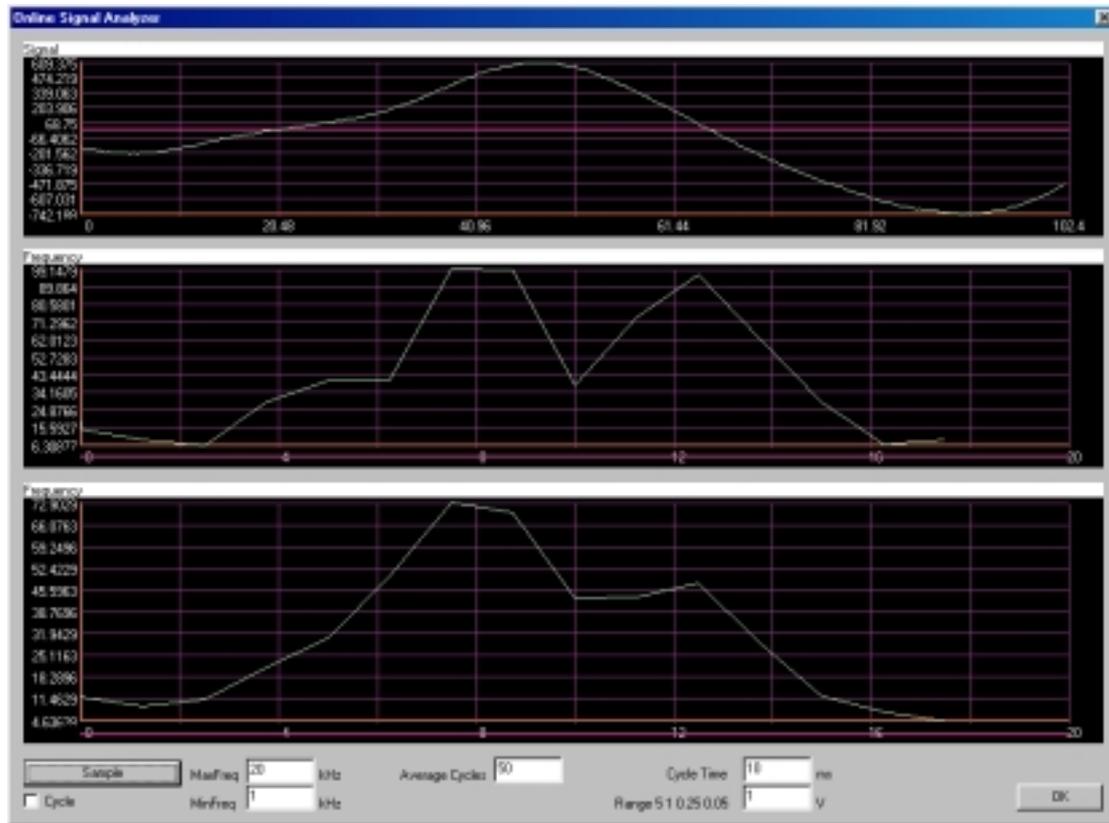
Figure 5 below show the frequency spectrum measured with the external clamp-on transducers. Now with a frequency scale of 0 – 20 kHz.

**Figure 5: Frequency spectrum with external clamp-on transducers, 0-20 kHz.**

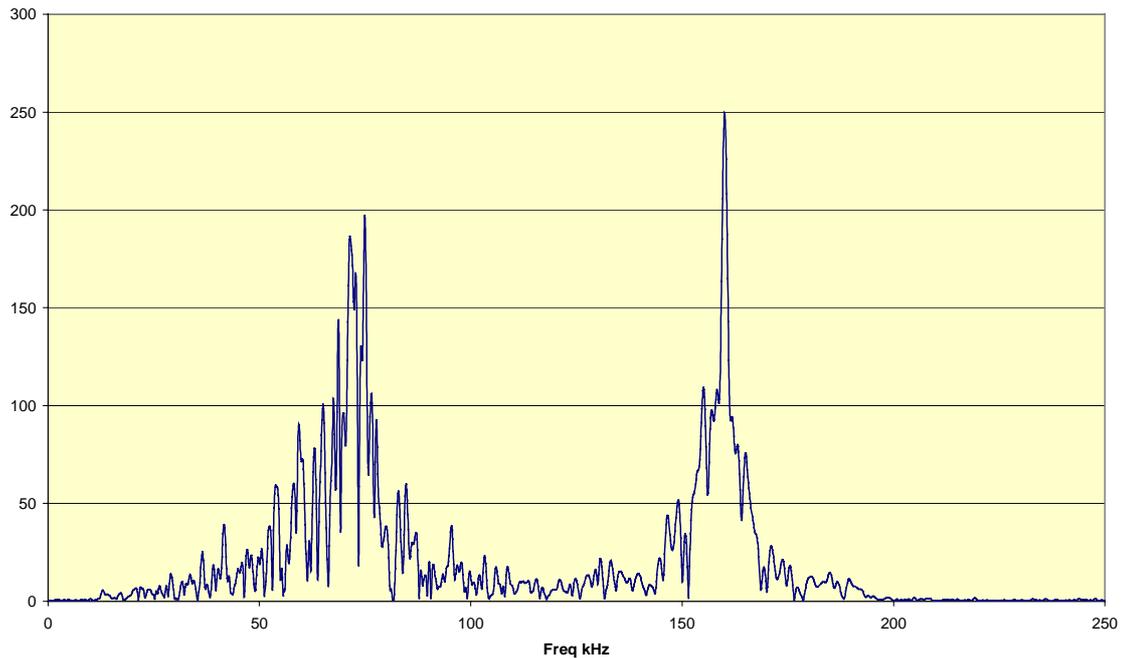
Measurements were also done with the transducers on the FMU 700 meters. From these measurements it became evident that there was considerable noise at about 70 kHz as well. This noise was very difficult to detect with the clamp-on transducers due to the extremely high amplitude of the noise at 9 kHz. The noise at 9 kHz were several hundred times higher in amplitude than the signal from the transducers.

The frequency spectrum as recorded by the FMU 700 prior to installing any filters can be seen in figure 6a below. Figure 6b shows the actual signal recorded.

**Figure 6a: Frequency spectrum recorded by the FMU 700 before installing filter**

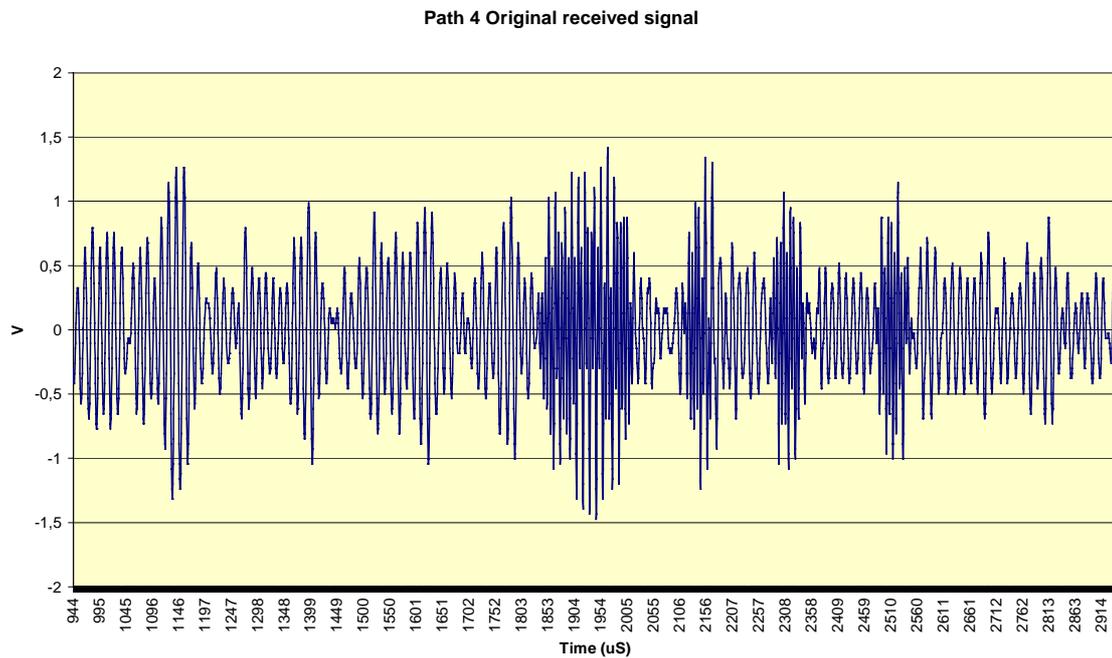
**Figure 6b: Received signal on path 4 by the FMU 700 before installing filter**

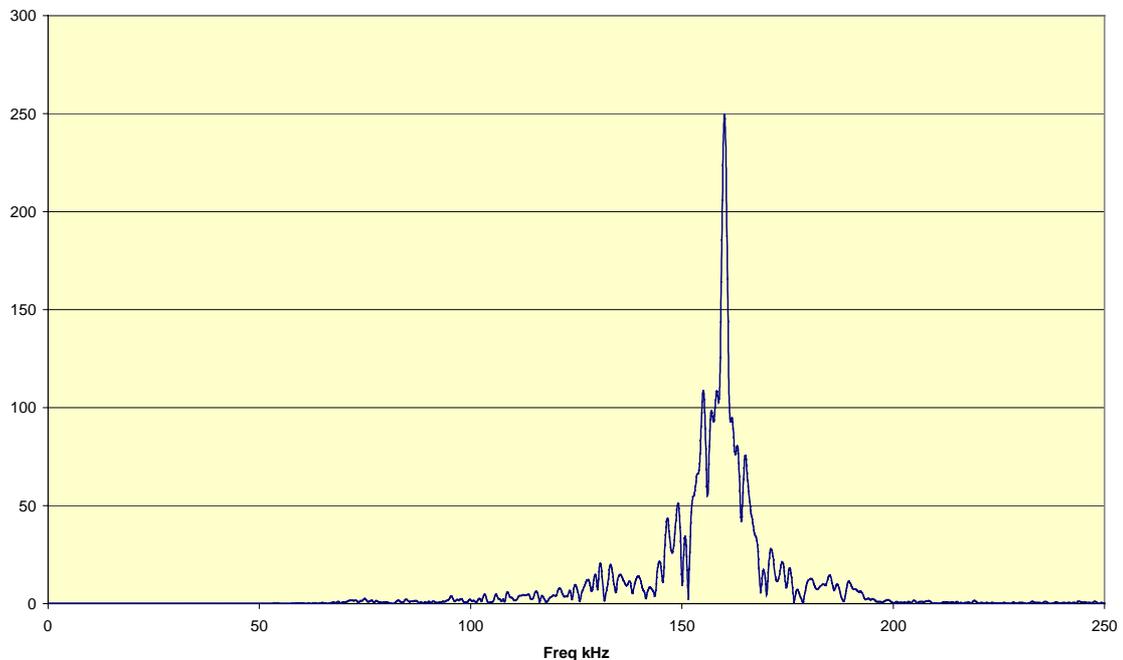
The frequency spectrum as recorded by the FMU 700 after installing analogue filters is shown in figure 7a below. Figure 7b shows the actual signal recorded.

**Figure 7a: Frequency spectrum recorded by the FMU 700 after installing filters**

As can be seen in figures 7a and 7b the amplitude of the noise level recorded by the FMU transducers is actually higher than the ultrasonic signal transmitted by the FMU itself.

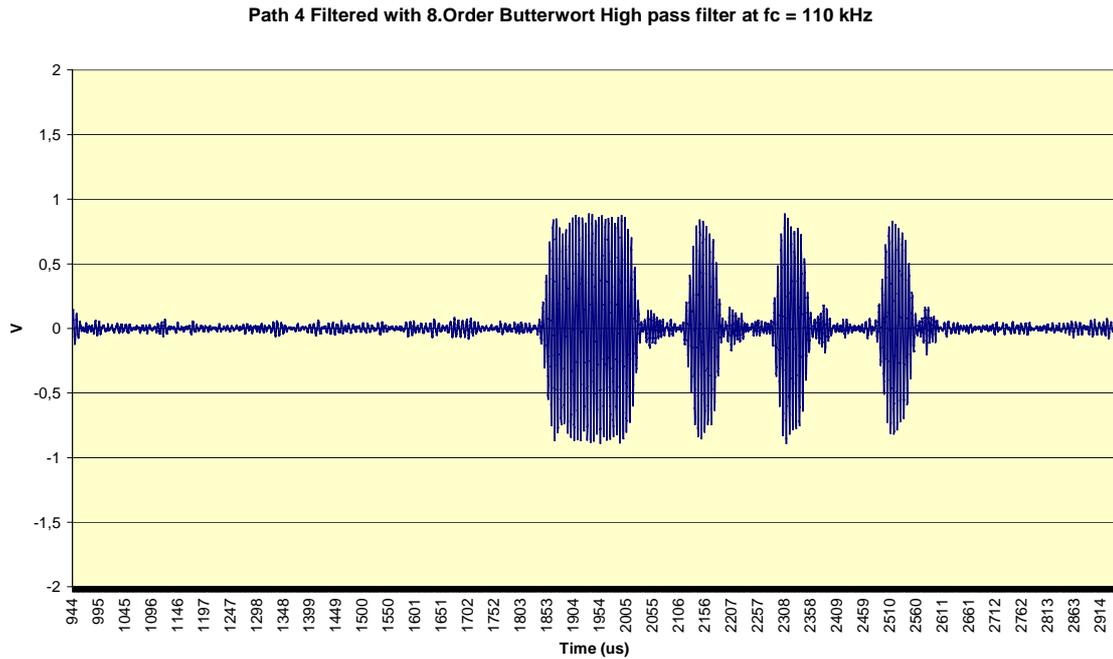
**Figure 7b: Received signal on path 4 by the FMU 700 after installing filter**

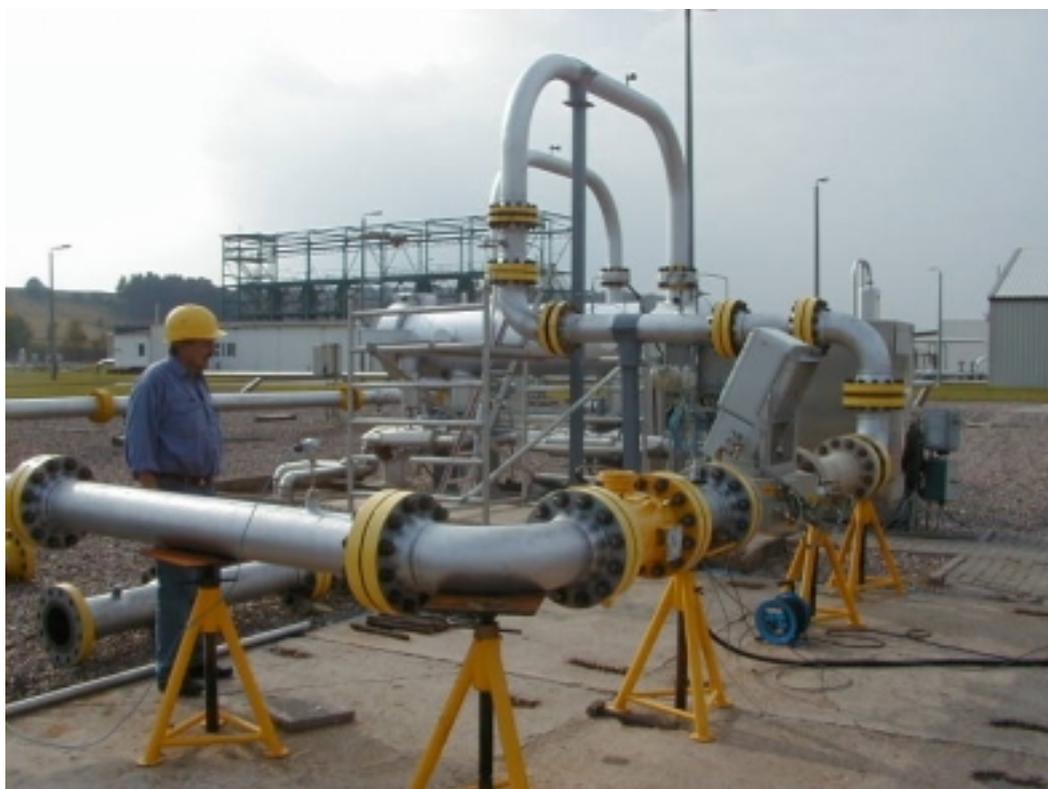
The MPU was installed downstream an above ground header as can be seen in figure 8 below. The piping goes vertically from the header, through two 90° large radius bends in the vertical plane, one 90° normal bend in the horizontal plane, and then the two bends out of plane immediately upstream the MPU.

**Figure 8: Installation at VNG**

One interesting observation was made during the extreme tests with the “half-moon-plate”. The turbine meter placed immediately downstream of the MPU (yellow spool in picture 1) showed more than 3% offset from the reference when the MPU was less than 1% offset.

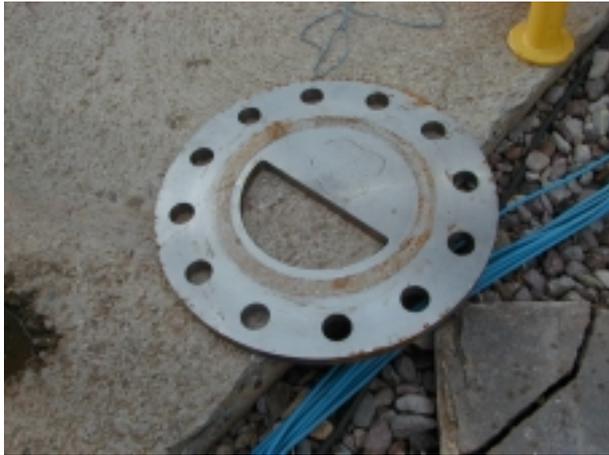
3. The meter placed 7D downstream of the second of the two out of plane bends with a high perturbation device or a "swirl-amplifier" installed between the two out of plane bends. This is the curve marked "RK+HB" in figure 11. The "half-moon plate" can be seen in figure 9.
4. The meter placed 7D downstream of the second of the two out of plane bends with a high perturbation device or a "swirl-amplifier" installed between the two out of plane bends, and a flow conditioner immediately downstream the second bend. This is the curve marked "RK+HB+GR" in figure 2. The flow conditioner used can be seen in figure 10.

Figure 9: "Half-Moon-Plate"

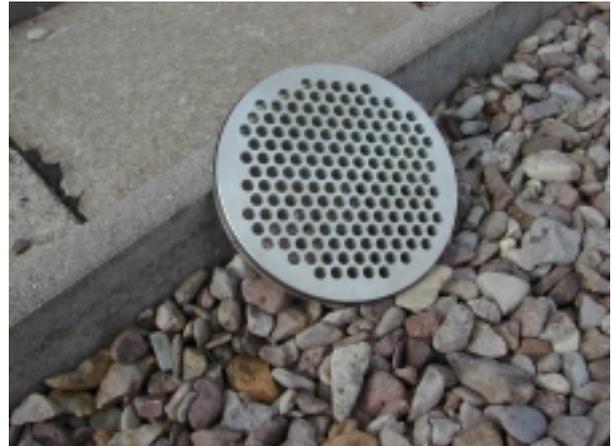
Figure 10: Flow Conditioner

5. The meter placed 3D downstream of the second of the two out of plane bends. This is the curve marked "RK" in figure 13.
6. The meter placed 3D downstream of the second of the two out of plane bends with a high perturbation device or a "swirl-amplifier" installed between the two out of plane bends. This is the curve marked "RK+HB" in figure 13. The "half-moon plate" can be seen in figure 9.
7. The meter placed 3D downstream of the second of the two out of plane bends with a high perturbation device or a "swirl-amplifier" installed between the two out of plane bends, and a flow conditioner immediately downstream the second bend.. This is the curve marked "RK+HB+GR" in figure 13. The flow conditioner used can be seen in figure 10.

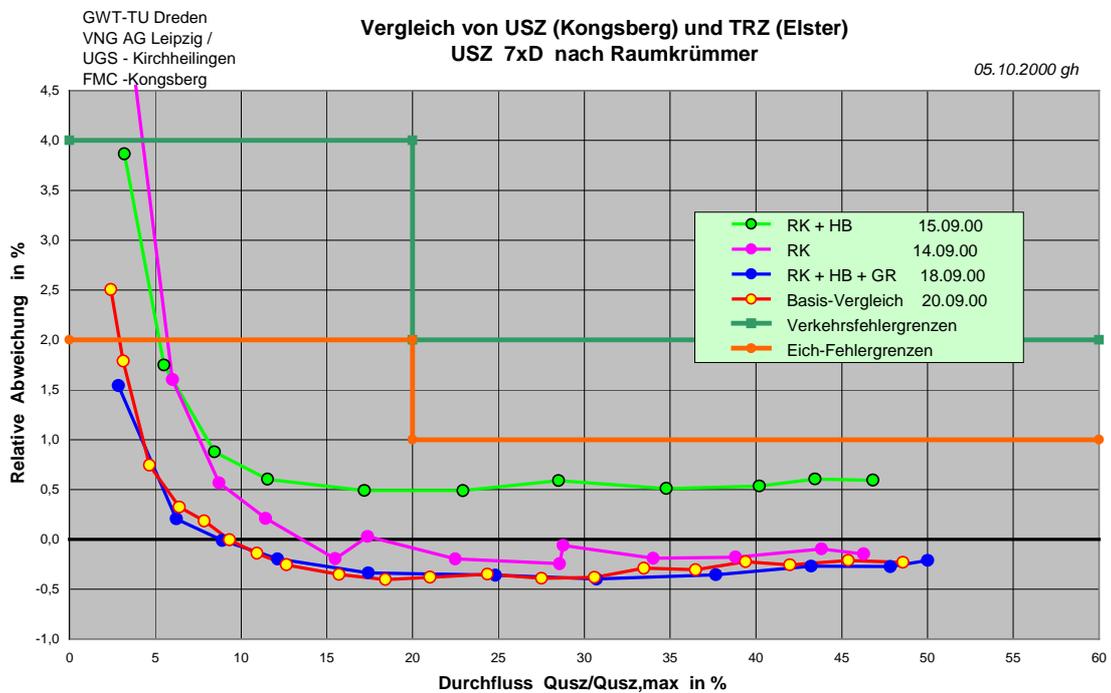
1. A basis or reference test, where the meter was placed with more than 100D straight upstream length. This is the curve marked "Basis-vergleich" in figure 11 and "BASIS" in figure 13.
2. The meter placed 7D downstream of the second of the two out of plane bends. This is the curve marked "RK" in figure 11.

Figure 11: VNG 7D results

The y-axis in figure 11 above and figure 13 below is the percent difference from the reference. The x-axis is the actual flowrate in percent of the maximum flowrate. This

The meter had previously been flow calibrated at the Ruhrgas Pigsar facility and the linear correction factors A and B, in the form  $Q = A \cdot Q_0 + B$ , had been implemented. The base test results from test 1 show that the offset of the meter is less than 0,5% from the reference.

With the meter placed 7D downstream of the double bends in test 2, the offset is approximately within 0,2% of the base results which also is within the repeatability of the meter.

Test 3 however, where the “half-moon-plate” is also placed upstream, the MPU performance shifts about 1% from the base test.

Test 4 shows that a flow conditioner is able to bring the extreme conditions in test 3 to conditions easily measured by the MPU.

When comparing the Lintorf results in figure 17 with the ones from the VNG figures 11 and 13 above they give us reason to conclude that the secondary flow patterns created by the high level perturbation device increase with the flow velocity. The MPU is able to compensate for the effects up to the approximate 7 m/s velocity at VNG but not with the higher velocities at Lintorf.

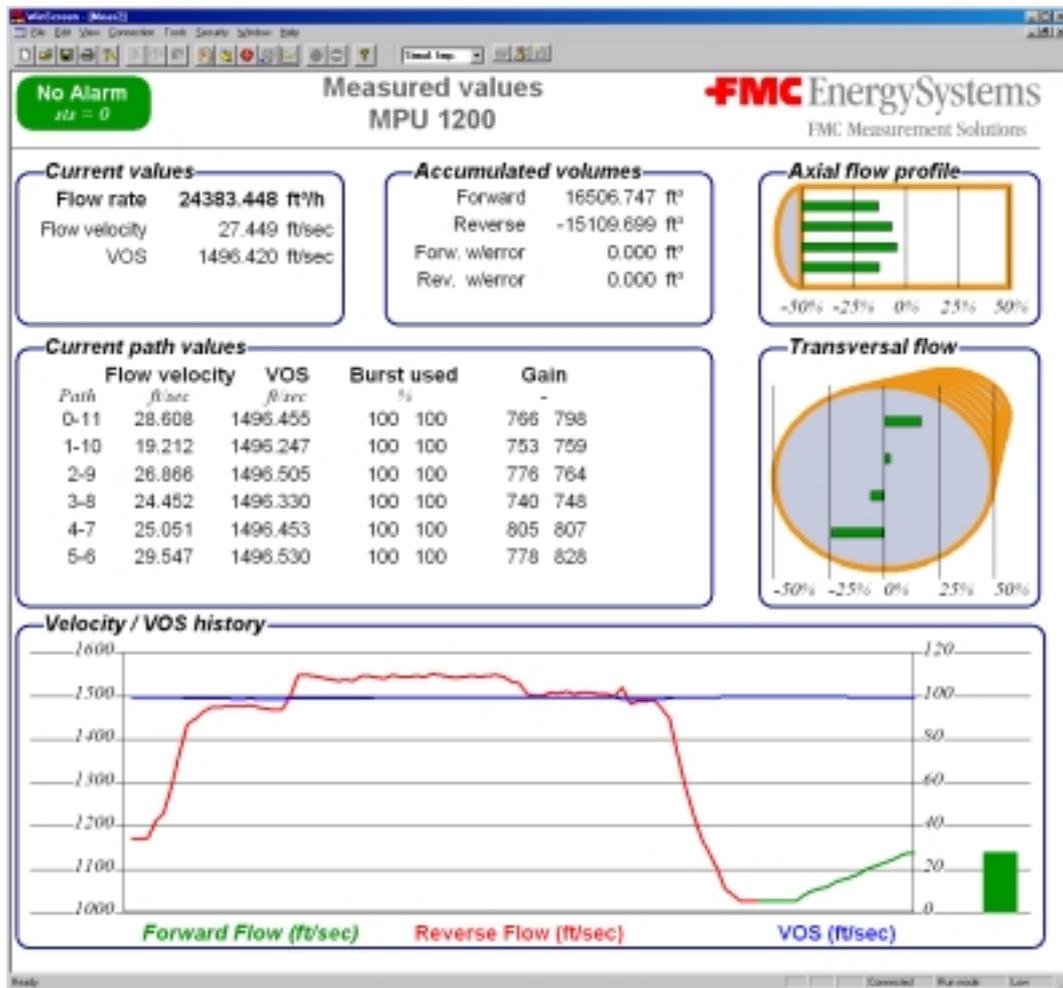
resulted in that 25% was approximately 3,5 m/s and 50% was approximately 7,0 m/s gas flow velocity.  
 The screen below shows a typical picture from the MPU WinScreen program when the MPU 1200 is subjected to similar swirl conditions as on VNG.

Figure 12: MPU WinScreen showing typical swirl conditions

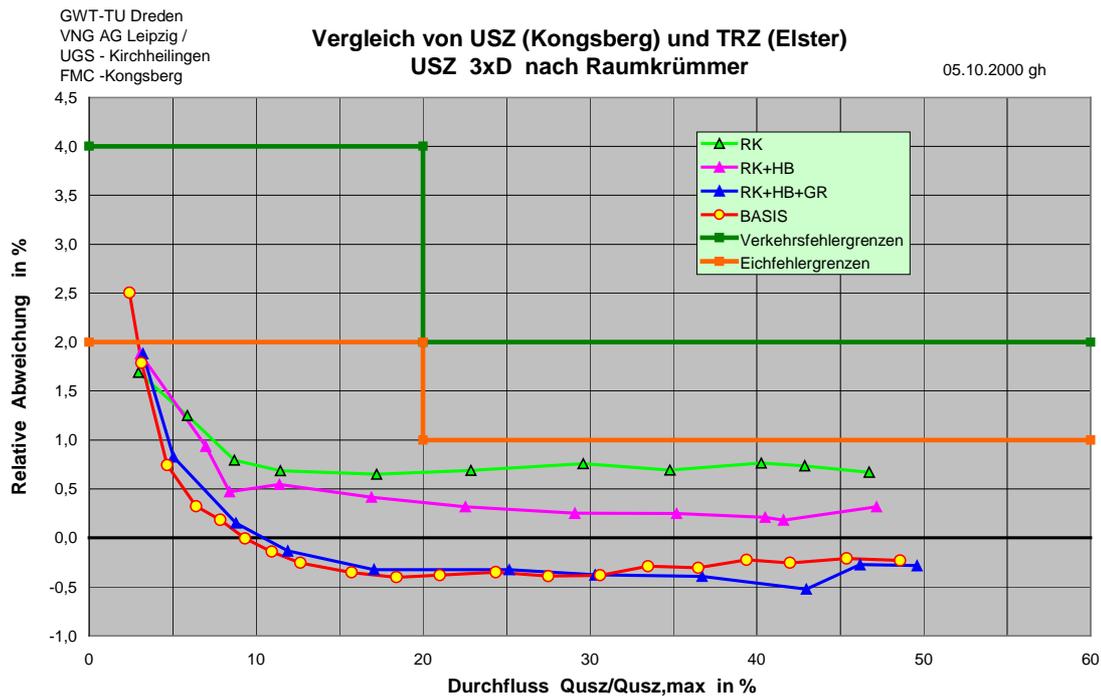
After the first series of tests with the meter installed 7D downstream of the double bend were completed, the MPU was moved to a position 3D downstream of the double bend and the following tests were carried out:

Figure 13: VNG 3D results

Similar results can be seen in tests 5-7 with the meter 3D from the out of plane bends, with the difference that test 5 also shifts the MPU results to approximately 0,6% above the base results. Again, with the flow conditioner the results are practically the same as for the base test.

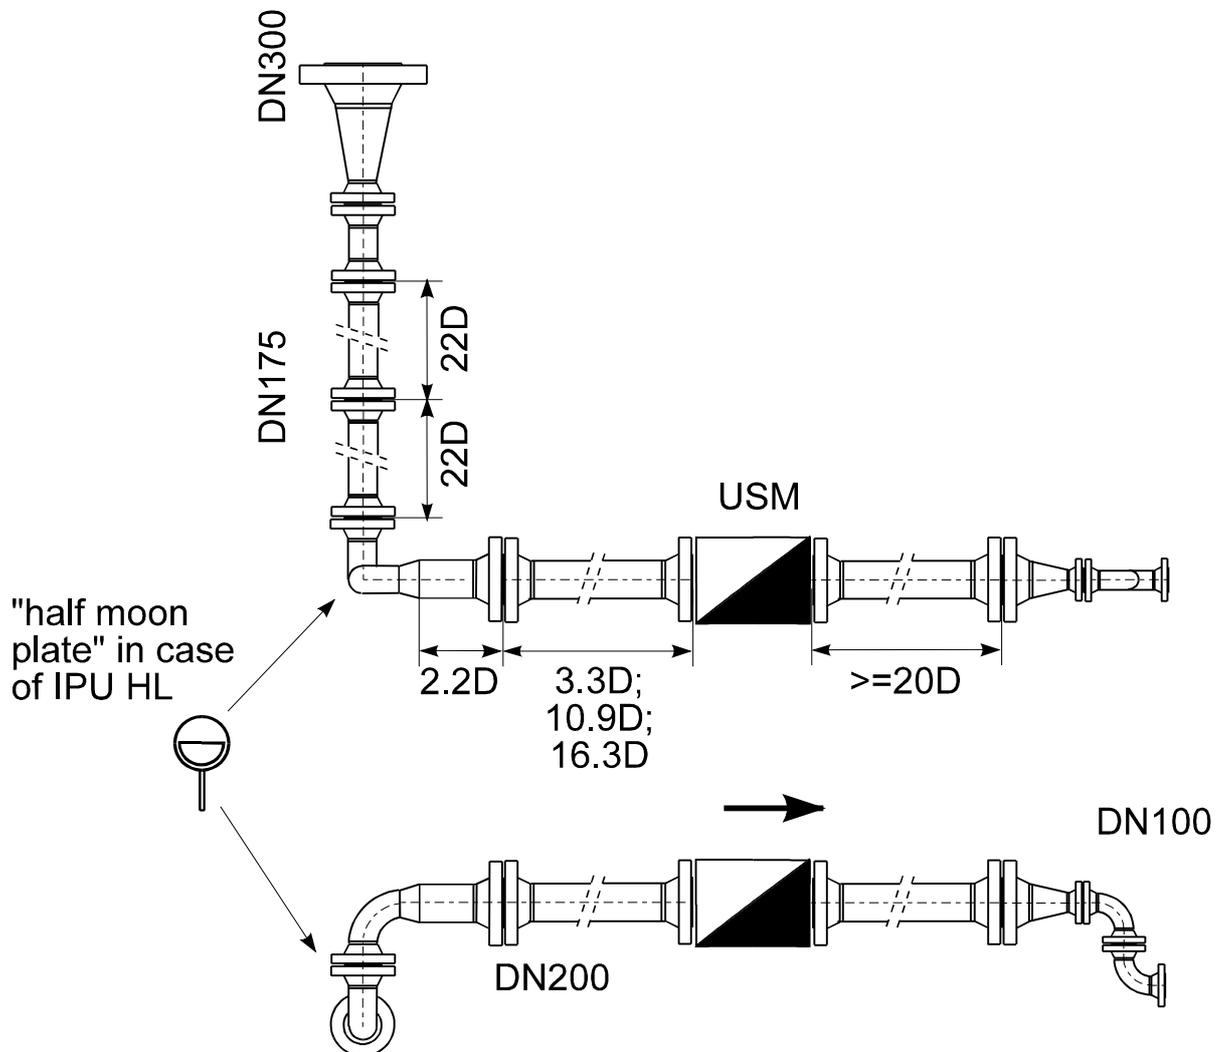
The MPU 1200 was installed downstream of two double bends out of plane with and without an ISO HL High Level perturbation device placed between the two bends. The installation at Lintorf can be seen in figure 14 below.

**Figure 14: Installation for ISO LL and HL perturbation tests, top and side view**

The ISO perturbation units (IPU) were initially designed to test turbine meters under disturbed conditions, see e.g. ISO 9951 and CEN prEN 12261. The so called low

level (LL) version consists of two elbows out of plane with a downstream diffuser in the form of an enlargement in pipe diameter, in this case from 175 mm to 200 mm, as defined in e.g. ISO 9951. High swirl and axial profile deformations are produced by the IPU LL. The high level version (HL) consists additionally of a half-moon-plate installed between the two bends. The axial profile deformations are higher and also instationary effects are higher due to flow separation. The IPU HL simulates flow perturbations produced by regulators and valves.

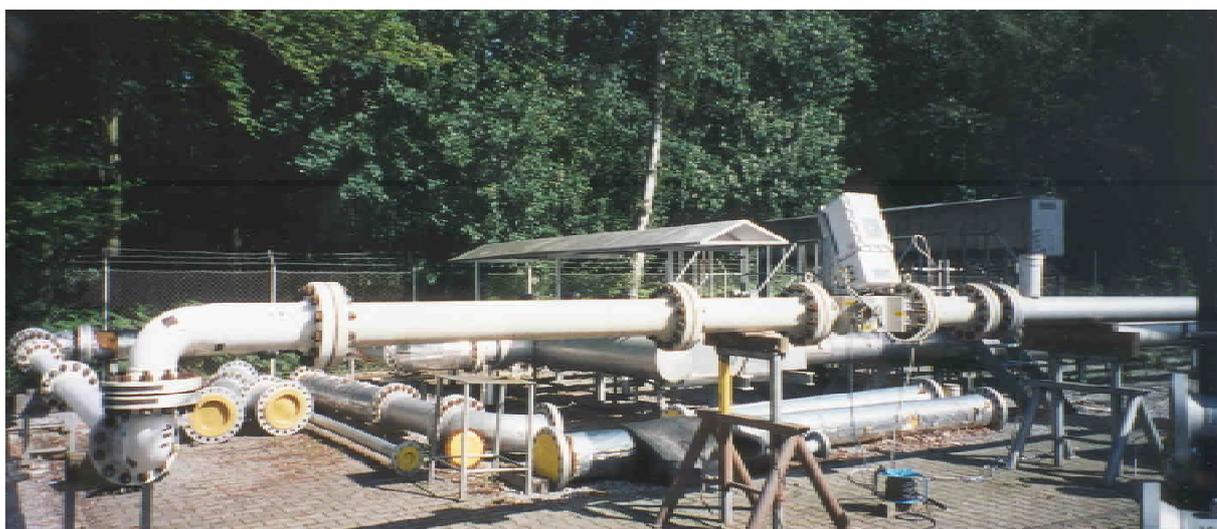
Below is a picture from Lintorf with the USM in the 18.5D position.

**Figure 15: Lintorf installation**

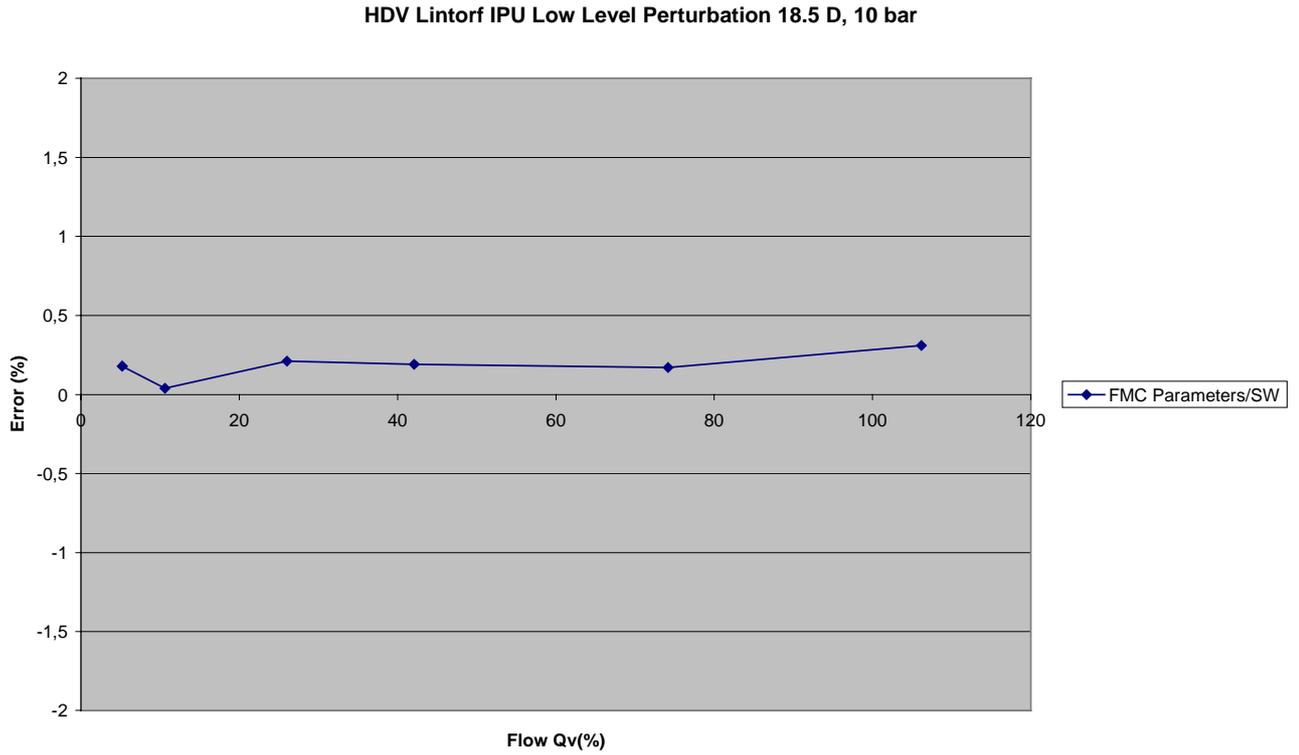
The x-axis in all graphs is the volume flow  $Q_v$  through the meter as percent of a maximum  $Q$  of 3470 m<sup>3</sup>/h. This volume flow gave a maximum gas flow velocity of 30 m/s through the 8" MPU 1200, which is the maximum velocity the meter is specified to.

1. IPU Low Level perturbation at 18.5D.  
The MPU was installed 18.5D downstream of the two out of plane bends and the diffuser. The results can be seen below in figure 16.

**Figure 16: Lintorf LL results**

The results in figure 16 show solid performance of the USM when placed 18.5D downstream of the two bends out of plane, as was also shown in the VNG tests above.

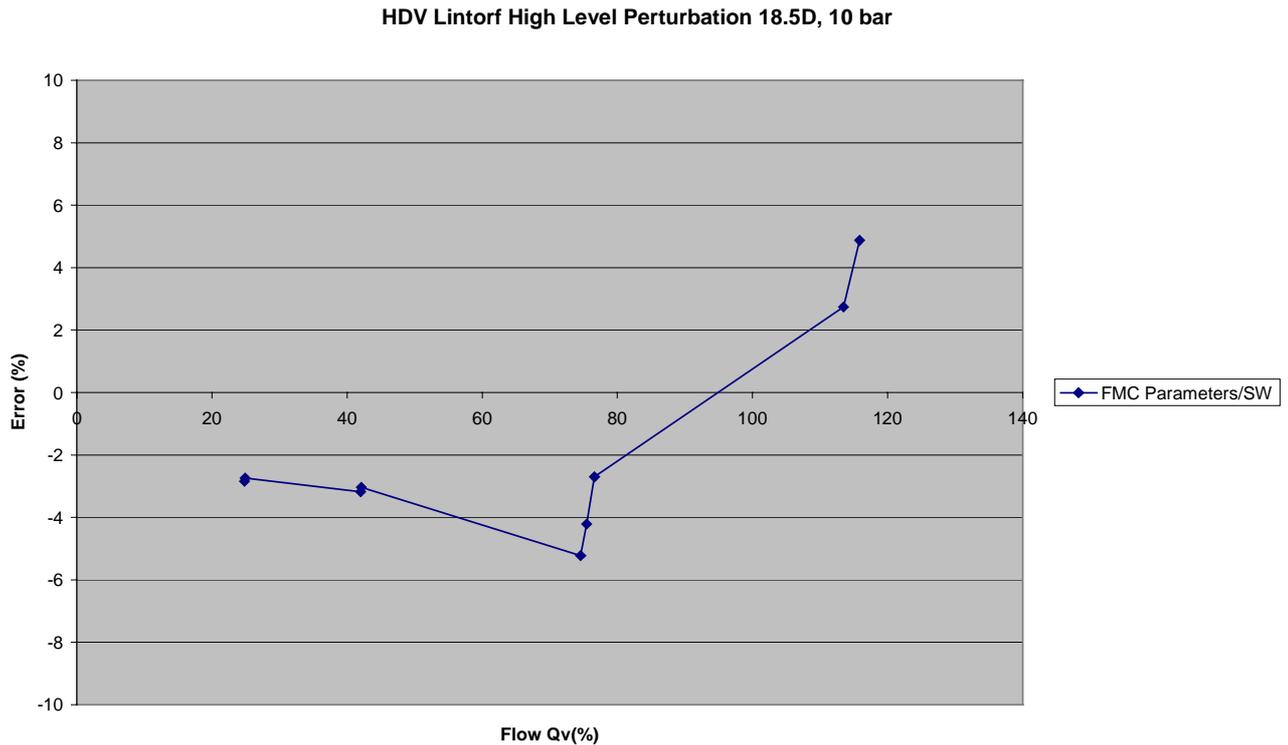
- IPU High Level perturbation at 18.5D.  
The MPU was installed 18.5D downstream of the two out of plane bends and the diffuser. During this test the “half-moon-plate” was installed between the two upstream out of plane bends as shown in figure 14. The results can be seen below in figure 17.

**Figure 17: Lintorf HL results**

The results in figure 17 however, show that placing the MPU 18.5D downstream of a double out of plane bend with a high level perturbation device, or any other part producing similar disturbances, is pushing the MPU beyond its limits.

Individual path data from the MPU shows that the transverse velocity components are higher than 100% of the actual mean flow velocity and this is really an extreme swirl condition. The MPU has simply not been designed to cope with such special conditions.

It can also be noted that the MPU actually measures even though the velocities go up to more than 115% of the maximum specified range of the meter.
