**Diagnosis and Mitigation of Contamination Build-up  
in Multipath Liquid Ultrasonic Meters  
on the Danish Oil Pipe**

**Dr Gregor J Brown, Cameron  
Lars Bach, DONG Oil Pipe A/S**

**34<sup>th</sup> International North Sea Flow Measurement Workshop  
25-28 October 2016**

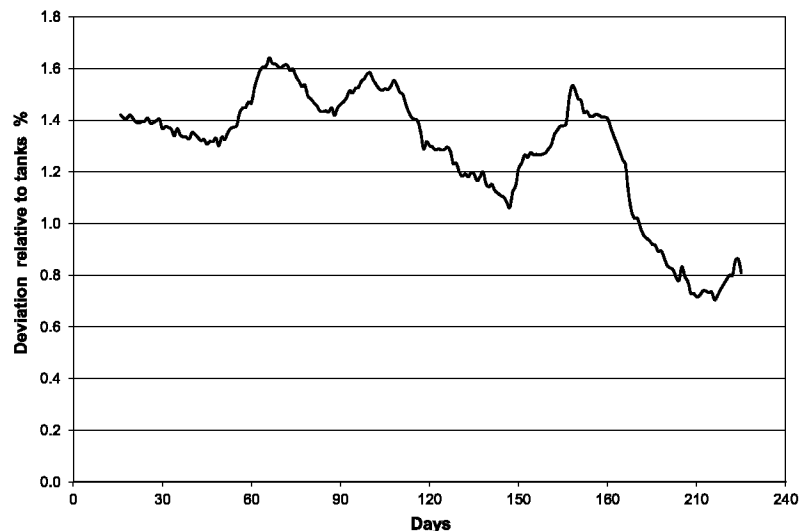
The performance of these meters on site, evaluated by means of comparison with the custody transfer tank gauging downstream, did not meet expectations. Over the course of time efforts were made to improve performance, for example by calibrating the 2-path meters with their upstream pipework, but still performance on site did not improve.

Figure 2 shows a trend of the deviation of one of the 2-path meters relative to the flow rate computed using the tank gauging at the DOP storage and export facilities. Flow rate comparisons in this paper between the tanks and flow meters are presented as a 20-day average to reduce 'scatter' in the data that results from various factors including data archiving methods and tank switching operations.

Fig. 2 - Typical performance of one of the 2-path meters

Following a visit to site by Cameron (Caldon) to review the installation, it was concluded that the upstream arrangement of bends in the metering system was non-ideal, as the arrangement of out-of-plane bends is well known to produce distortions of the axial profile and high levels of swirl. Therefore it was recommended that the 2-path meters be replaced by 4-path custody transfer grade meters, and that a flow conditioner be installed upstream to eliminate swirl. Nowadays, it would be usual to recommend an 8-path meter rather than a 4-path meter and conditioner, but at that particular point in time the Caldon 8-path meter for the petroleum industry had not yet been launched.

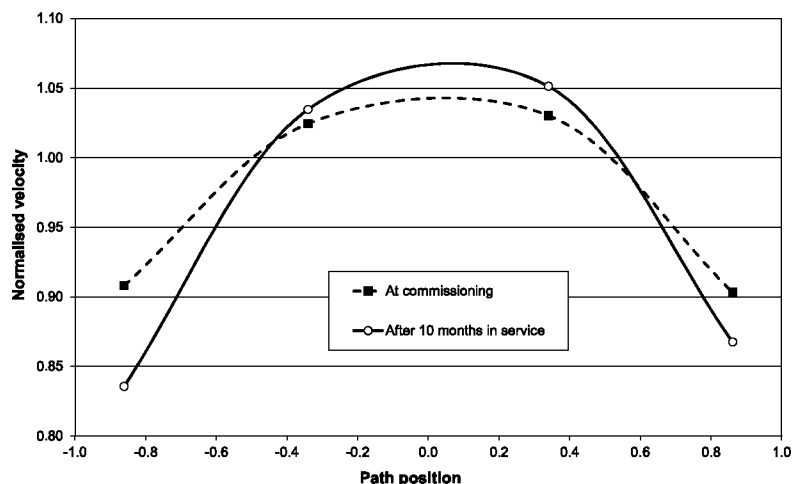
A diagnostic check had already been performed on the newly commissioned Meter 2 and had not highlighted any concerns. Therefore attention quickly turned to Meter 1 and a diagnostic log was taken from that meter for analysis. It was quickly determined, by analysis of various diagnostics, such as the velocity profile plot shown in Figure 5 below, that either the meter itself or the conditions of operation were different from what had been observed during commissioning.

Fig. 5 - Comparison of velocity profiles at commissioning and after 10 months in service (Meter 1)

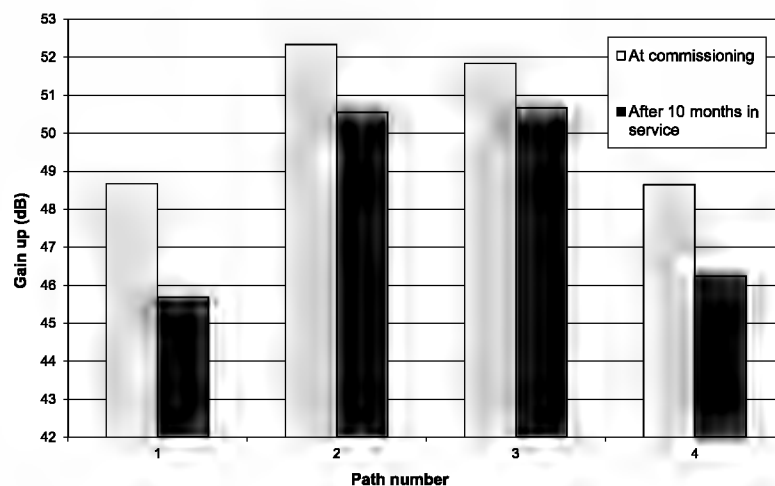
Of the various diagnostic parameters that were examined, it was noted in particular that the signal gain had reduced relative to commissioning. What drew attention to gain was that it had changed in a way that was not expected. As shown in Figure 6, the gain on the shorter, outside paths had reduced more than on the long paths. This was unexpected as the crude oil characteristics do not vary much and any change in absorption would be expected to affect the long paths more than the short paths. This led to a suggestion that perhaps the meter could be contaminated internally, as wax deposition could act like an acoustic matching layer on the stainless steel transducer housings of the meter. When this suggestion was made, the response from the technician on site was that, yes that could be the cause, as he had noticed that the decommissioned 2-path meters had been contaminated when they had been taken out of line.

Fig. 6 - Comparison of applied gain at commissioning and after 10 months in service (Meter 1)

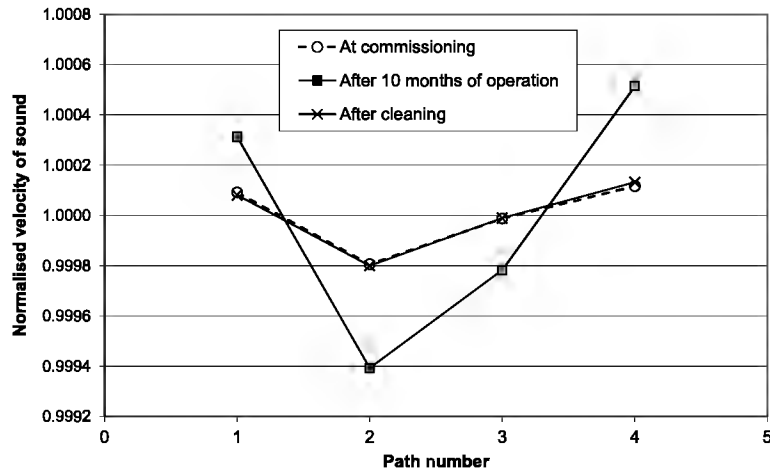
The next step was to take Meter 1 out of service again and clean it. When this had been completed the diagnostic indicators such as normalised velocity of sound (VOS) and Gain came back into very close agreement with the commissioning data (see Figures 16 and 17). Cleaning Meter 1 had the effect of reducing the difference between the two meters from ~0.9 % to ~0.2 %.

Fig. 16 - Velocity of sound comparison with commissioning baseline; after 10 months in service and following cleaning

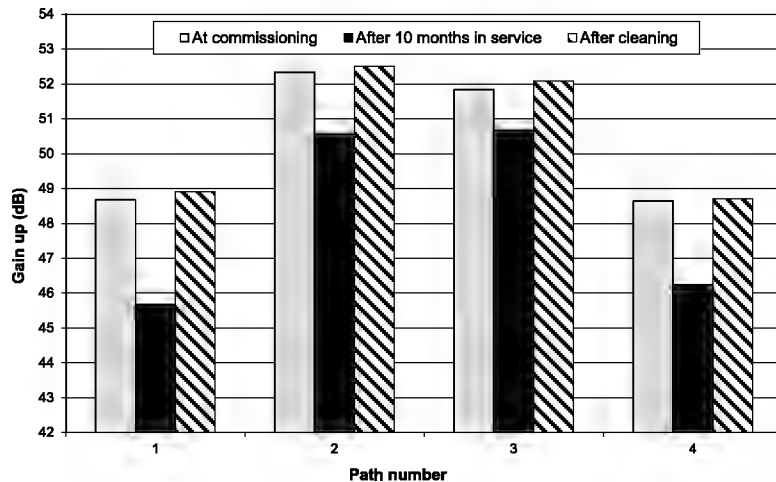
Fig. 17 - Gain comparison with commissioning baseline; after 10 months in service and following cleaning

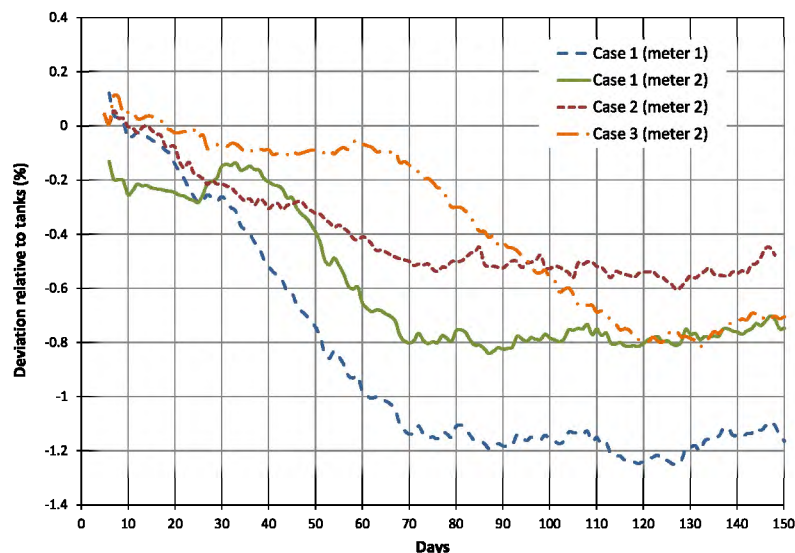
Diagnostic data logging was set up at site so that more information could be obtained while mitigation plans were discussed. It was also agreed that data from the tank gauging system downstream of the metering system would be examined so that the meters could be compared against an independent measurement. When this data was later analysed it was determined that the meters would be in good agreement with the tanks (and one another) when installed clean, and would stay that way for some time, which could be variable, but then they would begin to 'drift' relative to the tanks and then would settle at a fairly constant value somewhere between -0.5 % and -1.2 % relative to the tanks. Figure 18 below shows the deviation relative to the tanks, starting each time after a meter had been cleaned, and illustrates the variability of the deposition process and the resultant effect on the meters.

Fig. 18 - Flow rate deviation as a result of deposition, plotted versus time after cleaning, for three independent time periods

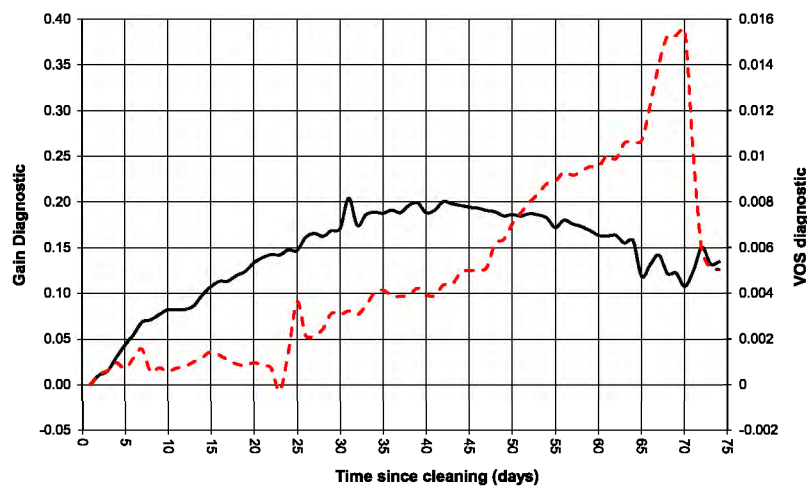
Figure 19 below show a gain diagnostic and a VOS diagnostic plotted versus the number of days since the meter was cleaned. This data corresponds with Case 1, Meter 1 in Figure 18 above. The Gain Diagnostic could easily be used to trigger an alarm in the first 10 to 15 days before the meter has shifted much, whereas the VOS Diagnostic does not give a clear indicate of a problem until around day 25, by which time the deviation was approximately 0.25 %.

Fig. 19 - Gain and VOS diagnostic monitoring, Case 1, Meter 1

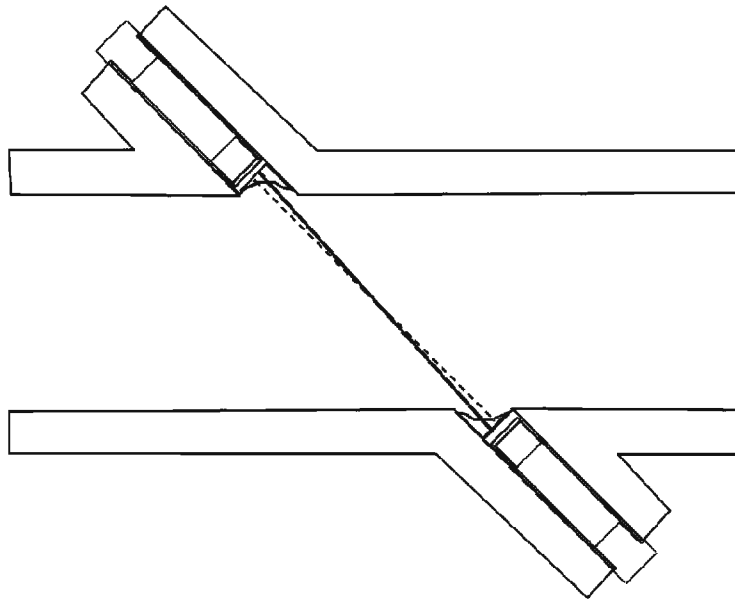
Analysing the data and considering the physics at work, it was concluded that the primary cause of the 'drift' was the deposition of material in the transducer housing cavities causing acoustic impedance changes and refraction effects and leading to a change in the path angle. This is illustrated in Figure 20. The angle between the path and the pipe axis increases, with the result that the measured transit time difference is reduced and the flow velocity is under-estimated.

Fig. 20 - An illustration of path angle change resulting from deposits forming in the transducer housing cavities

Ideas that were then discussed in terms of mitigating the contamination build up were as follows:

- Filling the cavities in front of the housings with an acoustically conductive material of some sort
- Increasing the length of the transducer housings such that they would protrude into the flow and eliminate the cavity
- Applying an adhesion resistant coating to the wetted surfaces of the meter body and transducer housings

Filling the cavities with some other material was ruled out on the basis that it would just create a refraction issue of a different sort, causing the path angle to change with variations in the sound velocity of the fluid, e.g. due to temperature changes.

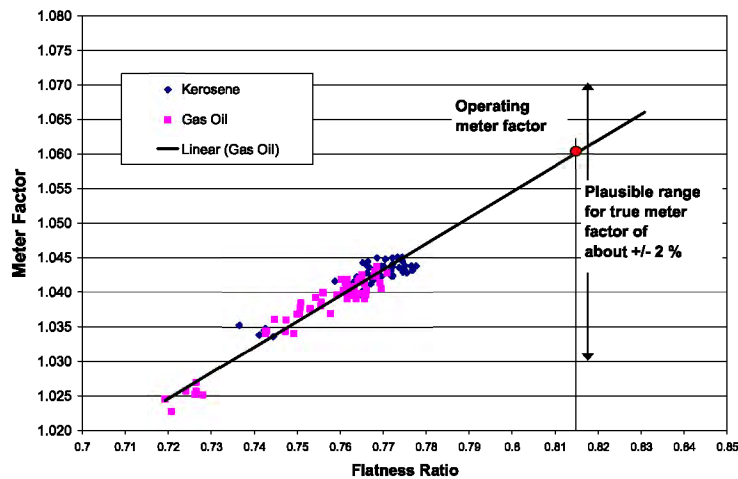
As the meter had been adjusted by means of the weighting factors, the effect on the meter behaviour is the same as applying a linear correction to the meter as a function of velocity profile flatness ratio. Figure 23 below shows the Trapil calibration data plotted in this way, with a point representing the operating condition at the time of commissioning. This shows that the operating condition at the time of commissioning was, in profile flatness terms, very far from the calibration conditions. Based on the comparison of Meter 1 with Meter 2 and with

the tank data it was clear that this linear extrapolation was not producing the desired measurement result at the field conditions.

Fig. 23 - Calibration of Meter 1 post modification and weighting factor adjustment

In an effort to overcome this issue, and considering that the meter was not a custody transfer meter, the weighting factor adjustment that had been applied to the meter at the calibration was removed and the meter re-linearised using the computed Reynolds number as the calibration correlation parameter. This removed the influence of the unusually high flatness and brought the two meters into closer agreement, though it appeared that the modified meter was still reading approximately 0.6 % higher than expected.

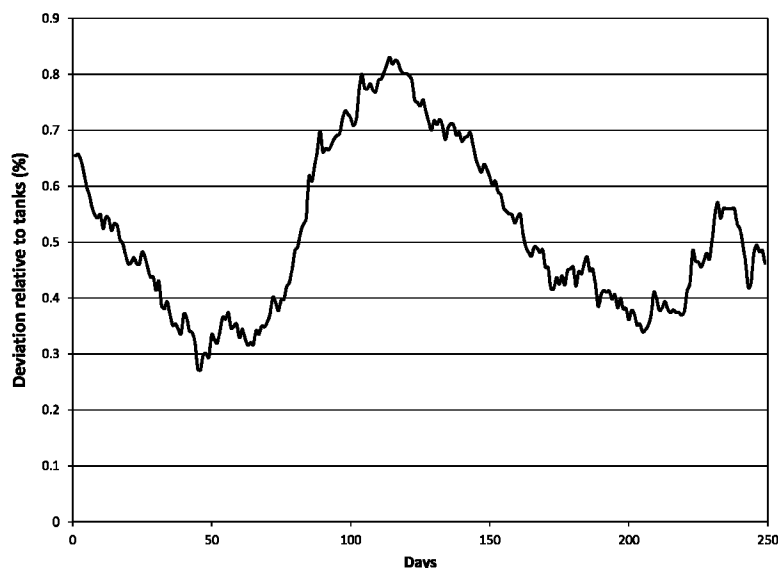
The modified meter was then monitored for a period of some months and in this time it was easily determined that it was not performing as well as had been hoped. Figure 24 below shows the response of Meter 1 after modification, relative to the tank gauges.

Fig. 24 - Comparison of Meter 1 (modified, with protruding transducer

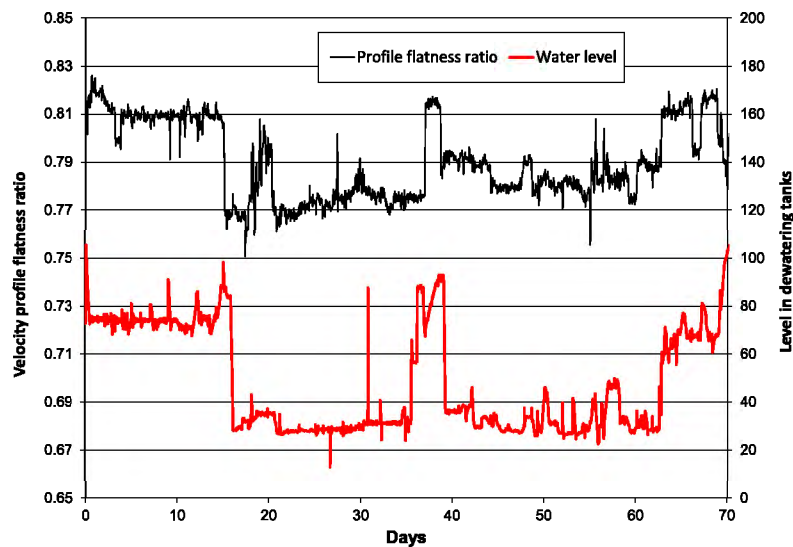
During the same time period, the influence and effectiveness of the drag reducing agent was discussed and it was noted that more DRA was used when the water content of the crude was high. Subsequent analysis showed that there was a degree of correlation between the water extraction flowrates and dewatering tank level indications at Fredericia and the indicated profile flatness, as shown in Figure 25 below. Given the suggestion that the DRA dose was increased when the water content of the crude is high, this was taken as corroboration that the profile flatness was varying in response to changes in the dosage of DRA.

Fig. 25 - Water content and profile flatness correlation, linking DRA injection rates to profile flatness changes

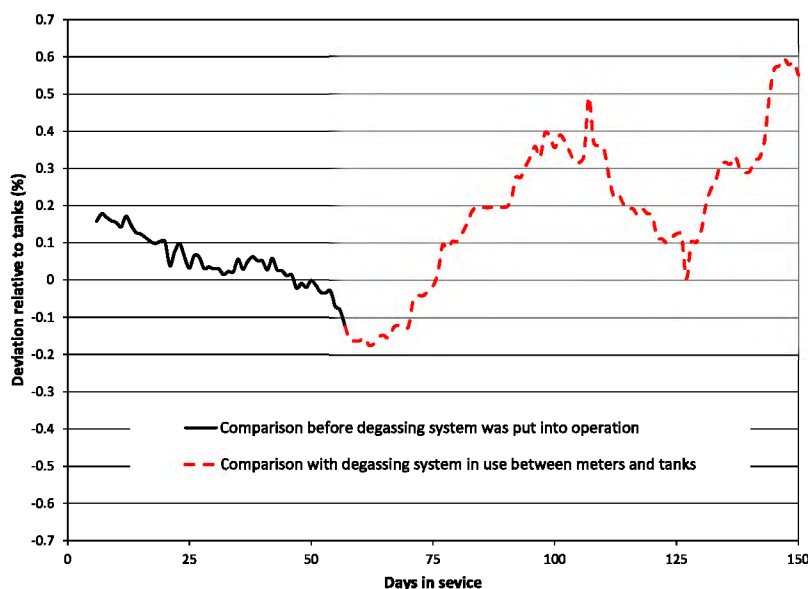
After Meter 2 had been coated, calibrated and installed, it was monitored relative to the tanks. When the data was analysed it appeared that the meter was relatively stable at first, showing a slight downward trend, and then changed its behaviour after a couple of months in operation. It was feared that contamination problems had developed again, but analysis of the diagnostic data did not suggest that was the case. The tank comparison data for this period is shown in Figure 28 below. Initially this data was baffling, as the comparison with the tanks suggested that after about 75 days in service the meters started over-reading. The 4-path meters with transducer housings recessed had never shown over-reading behaviour prior to this point, even when contaminated. As a result of much discussion and speculation it was then discovered that the date of the change in meter behaviour coincided with the commissioning of a new de-gassing facility. The degassing facility is situated between the metering station and the tanks. As a result, the comparisons that were being carried out were no longer valid as they did not account for the inventory change in the degasser tanks, nor the change in volume due to extraction of gas and additional water from the degassing facility. Figure 28 shows that it is only after the point in time when the degasser unit was brought online, 56 days into the operation of the coated meter, that the deviation begins to trend upwards.

Fig. 28 - Comparison the coated meter with the tanks, not accounting for the operation of the degassing system

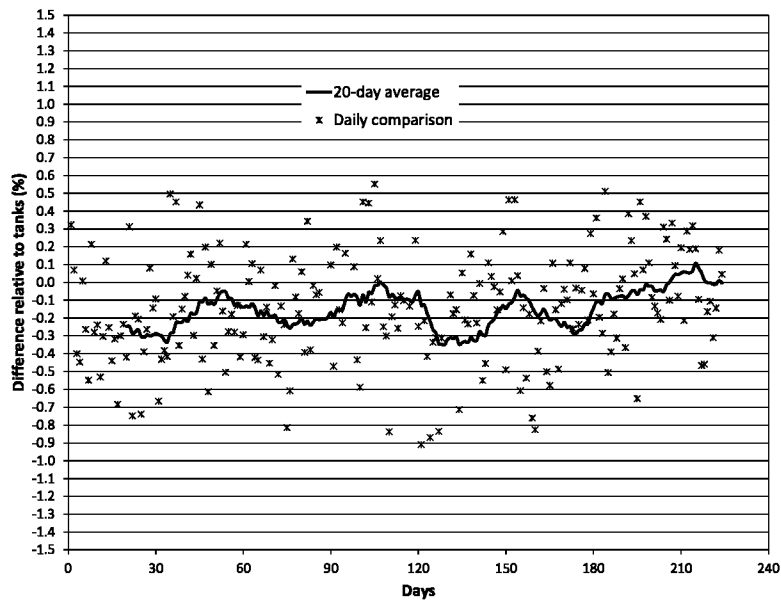
Figure 29 shows a longer-term comparison of the coated meter versus the tanks with corrections applied in an attempt to compensate for the volume changes owing to operation of the degassing system. It should be noted that this comparison is subject to significant uncertainty, as evidenced by the scatter in the daily comparison data. Given that uncertainty, it is difficult to ascertain if the fluctuations apparent in the 20-day average are influenced at all by contamination or if they are simply the result of the scatter in the daily comparisons. It is clear however, when compared with Figure 18, that there not the same systematic 'drift' due to contamination that was apparent with the uncoated meter.

Fig. 29 - Comparison the coated meter with the tanks, including corrections for water and gas extracted, level changes, and recovered oil added

Following the evaluation Meter 2 after modification (coated and with transducer housings recessed as normal), Meter 1 was returned to the factory and made the same as Meter 2. Subsequent diagnostic checks and periodic inspections have shown that the meters are not completely free from the effects of contamination. However, the coating applied to the meters has substantially reduced the build-up problem. Figures 30 and 31 show photographs of the interior of Meter 2 after it had been coated and had been in service for approximately 10 months without cleaning. Although the interior surfaces are not free from contamination, it was observed that the contaminants have greater difficulty in adhering to the coated surface than they did with stainless steel, and in some places it appeared that the flow had stripped the contaminants off of the pipe wall, leaving the coated surface clean. Of particular importance it was observed that the problem of contamination build-up forming in the cavities of the upstream transducer housings was significantly reduced, as can be observed by comparing Figure 31 with that of Figure 15, which both show the deeper cavities of the outside paths. In the case of the uncoated meter the deposition covers the whole of the interior of the cavity and the face of the housing. With the coated meter there is much less deposition and it appears not to have consolidated in the same way as for the uncoated meter, suggesting the coating results in a 'self-cleaning' effect.
